DAMAGES IN CONCRETE RAILWAY SLEEPERS IN FINLAND

Pirjo Tepponen, Bo-Erik Eriksson
Lohja Corporation, Product Development

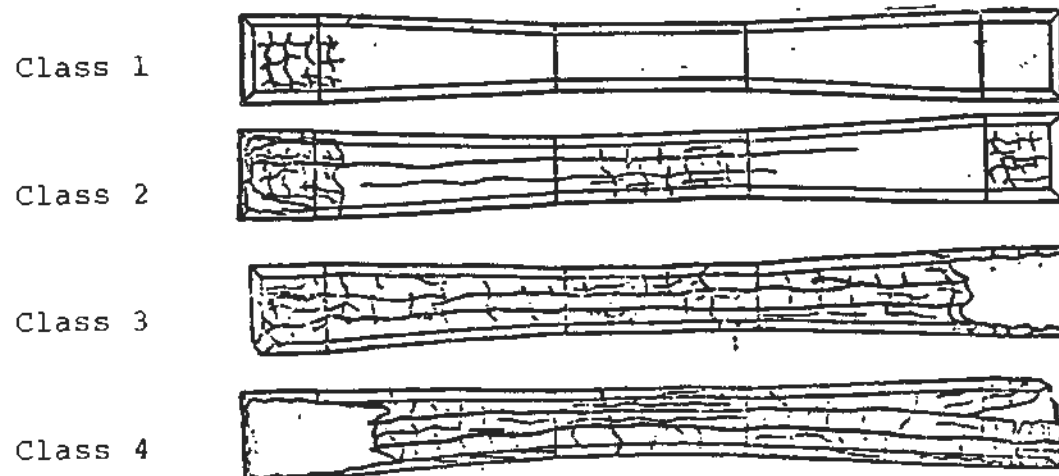
Figure 1. Progressive development of deterioration process

Damages develop progressively in the sleepers. The stages of deterioration have been grouped into four classes with an estimate of the remaining service life of the sleepers.

Stage 1 Class 1. Netlike capillary cracking on the top surfaces of sleepers ends. Estimated remaining service life about 10 years.

Stage 2 Class 2. Longitudinal cracks and minor fractures. Service life about 5 years.

Stage 3 Class 3. More cracks and fractures. Concrete comes off the sleeper. Service life about 1 year.

Stage 4 Class 4. Prestressing bars are visible. Rail fastening has come out or the sleeper is broken. Replacement required immediately.

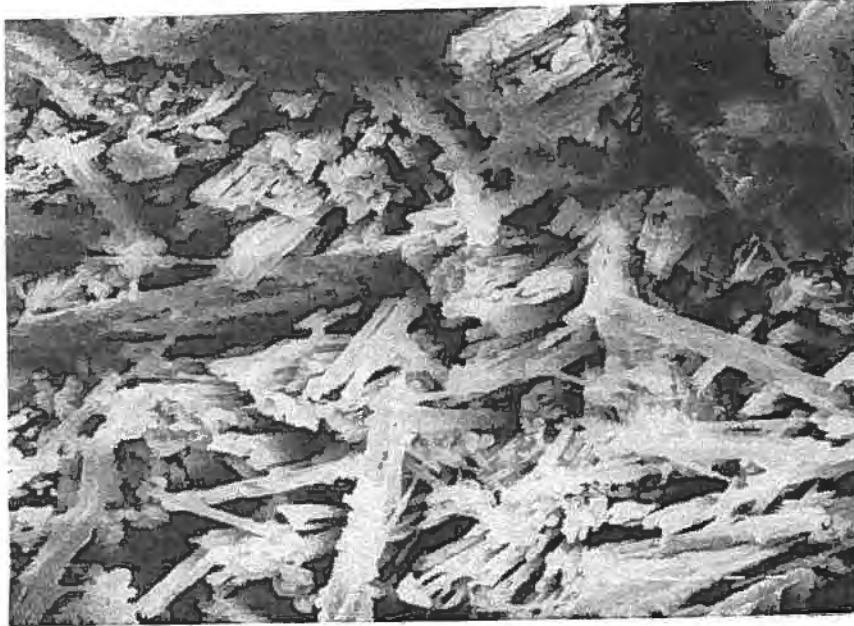
The examinations revealed a great number of microfissures in some places. Partial filling up of pores and cracks was observed in all the examined sleepers dating from the 1960s or 1970s. The degree of filling correlates with the number of microfissures; practically all the pores and some of the larger cracks were found to be filled up in the more deteriorated sleepers.

The combination of SEM-EDAX revealed the pores and cracks to be filled up with macrocrystalline ettringites, which was confirmed by X-ray diffraction later on (figure 4). The ettringite had accumulated in the free space; cement gel showed no nucleation centres for formation of fissures.

Figure 4. a) Air pores filled with ettringite

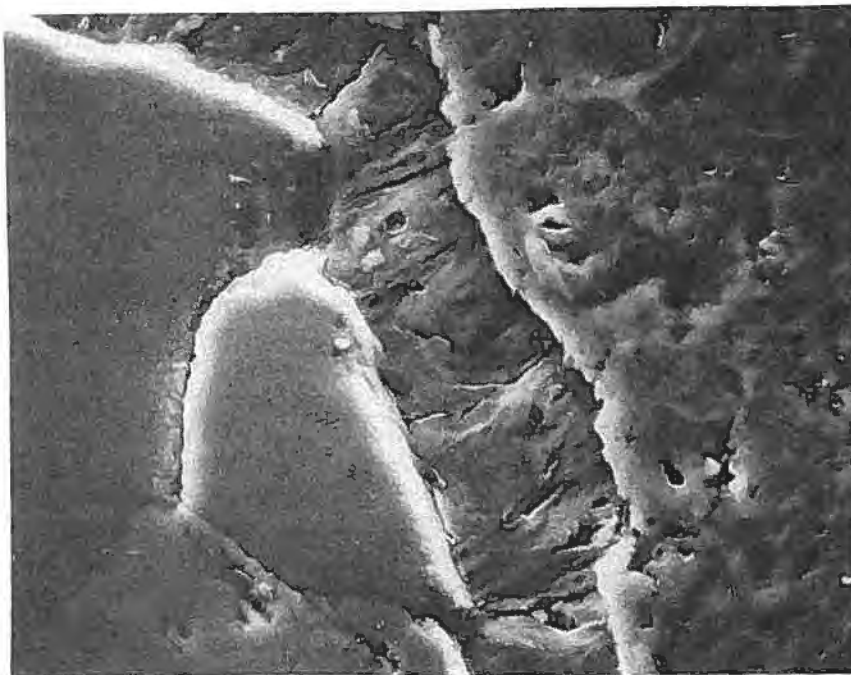
In the more deteriorated sleepers the bond between large stones and cement gel was found to be poor. The pattern of fissures followed the edges of the stones.

Figure 4. b) Totally filled up crack between stone and cement gel
