CARBONATION OF REINFORCED CONCRETE FACADE PANELS - A FIELD INVESTIGATION

Matti Pentti
M.Sc., Researcher
Department of Civil Engineering
Tampere University of Technology, Finland

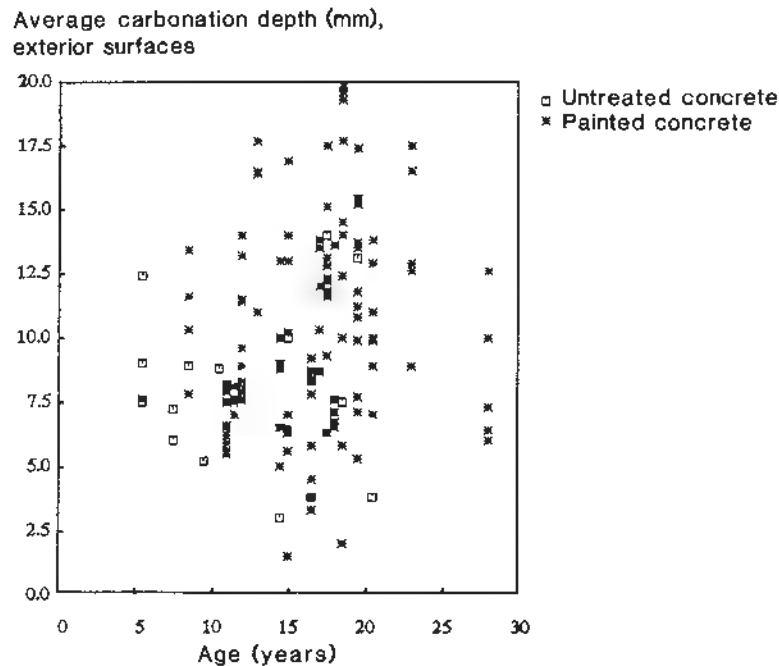
Variation in the depth of carbonation with age for painted and untreated exterior surfaces is shown in Fig. 3. It can be seen that the results are widely dispersed. Variation in the coefficients of carbonation k calculated from the formula $x = k \sqrt{t}$, where x is the measured average carbonation depth (mm) and t is time (years), is shown in Fig. 4. If we assume that the carbonation progresses according to the square root model, and the covers exceed 25 mm, it follows that most of the investigated panels should reach a service life of over 50 years.

Fig. 3. Measured average carbonation depths plotted against age of panels (painted and untreated exterior surfaces).

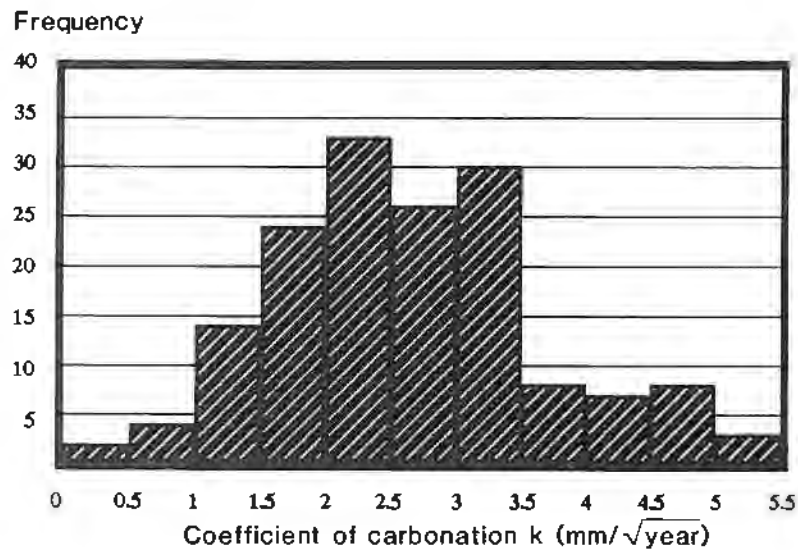
Fig. 4. Distribution of coefficients of carbonation calculated from square root model (painted and untreated exterior surfaces).

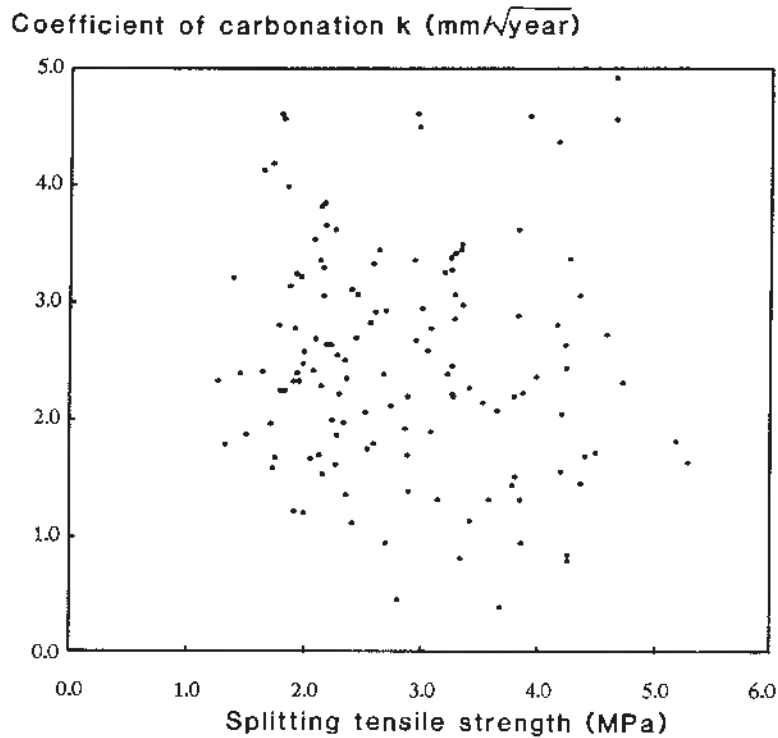
The coefficients of carbonation did not correlate significantly to the splitting tensile strengths (Fig. 5).

Fig. 5. Coefficients of carbonation plotted against splitting tensile strength.

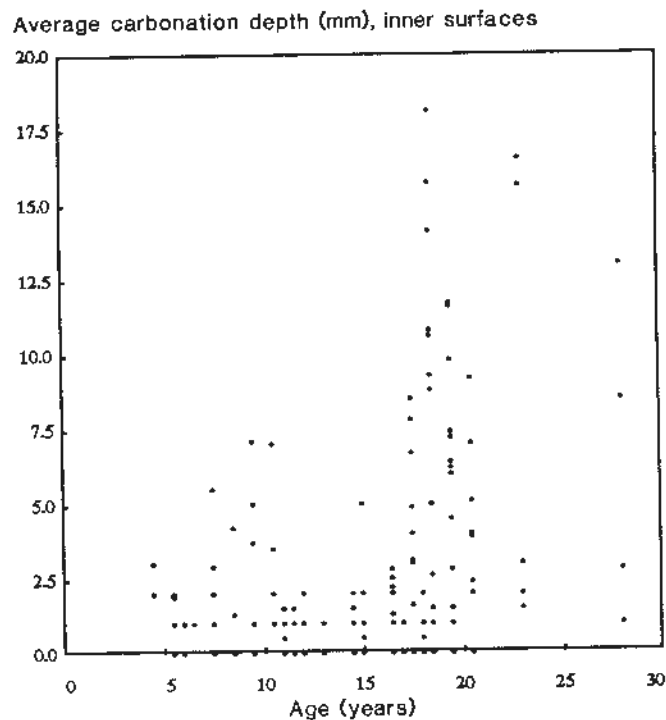
There is usually no ventilation space between the exterior panel and the thermal insulation (rockwool) in Finnish sandwich structures. However, if the panel has e.g. ceramic tile cladding, the insulation boards are provided with ventilation grooves. The rate of carbonation at the inner surfaces of the exterior panels proved to be lower than on the outer surfaces (Fig. 6). 37 % of the measurements at the inner surfaces showed no evidence of carbonation. The measurements from ventilated structures showed that ventilation accelerates the rate of carbonation compared with non-ventilated structures. Carbonation rates near the ventilation grooves can be as high as on the exterior surfaces of the panels.

Fig. 6. Measured average carbonation depths plotted against age of panels (inner surfaces of external panels).

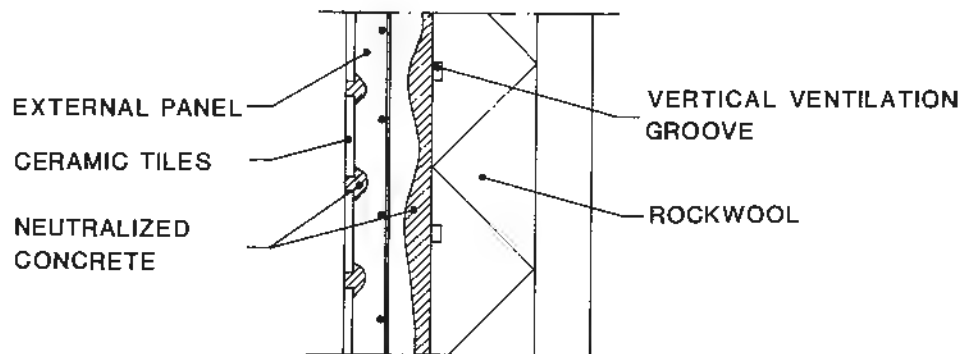
Ceramic tiles proved effective in preventing carbonation. 25 samples were taken from surfaces with ceramic tile cladding but only two of them had a carbonation depth above zero. The age of the panels varied from 10 to 22 years. The carbonation front was found to penetrate to the concrete-filled joints between the tiles only; there the measured rate of carbonation was slower than on untreated surfaces (Fig. 7).

Fig. 7. Carbonation of sandwich panels with ceramic tile cladding.

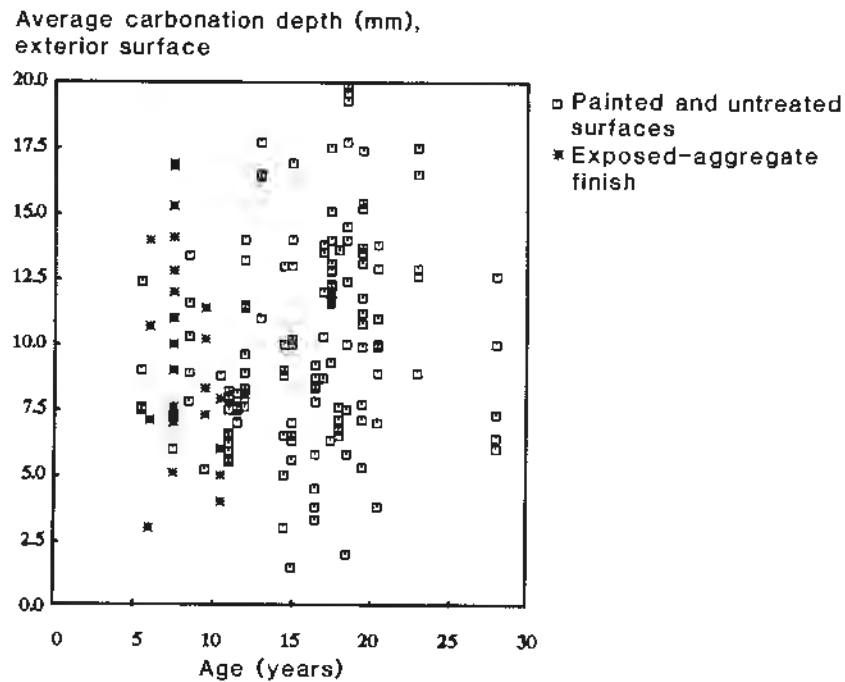
Exposed-aggregate finishes showed a faster rate of carbonation than painted and untreated concrete surfaces (Fig. 8). The reason for the faster carbonation rate is probably the greater permeability of the exposed-aggregate concrete, resulting from the mix, the grading of aggregate, the low thickness of the layer in casting and the effect of admixtures and washing treatment.

Fig. 8. Carbonation depths of exposed-aggregate finished panels with age compared with painted and untreated samples.

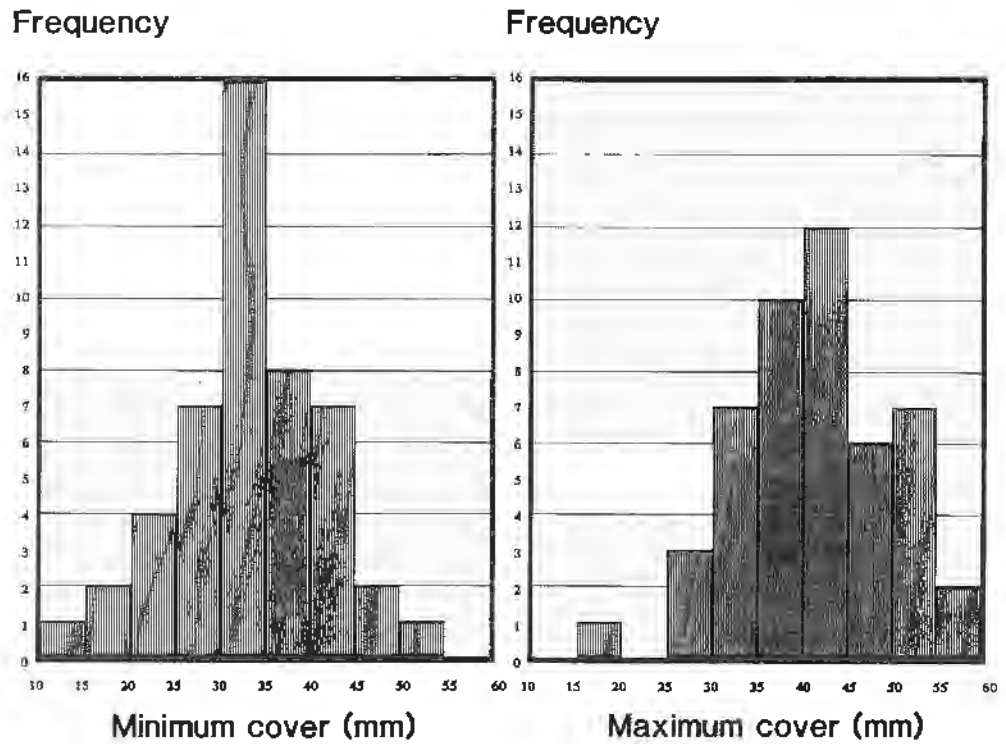
The minimum and maximum covers of reinforcement were measured with a covermeter from two randomly chosen areas of 0.5 m² in each building. The results obtained from painted facades are shown in Fig. 9.

The measured thicknesses of concrete cover fulfil quite well the minimum cover requirement of 25 mm set by the official concrete code.

Fig. 9. Distributions of measured minimum and maximum cover.

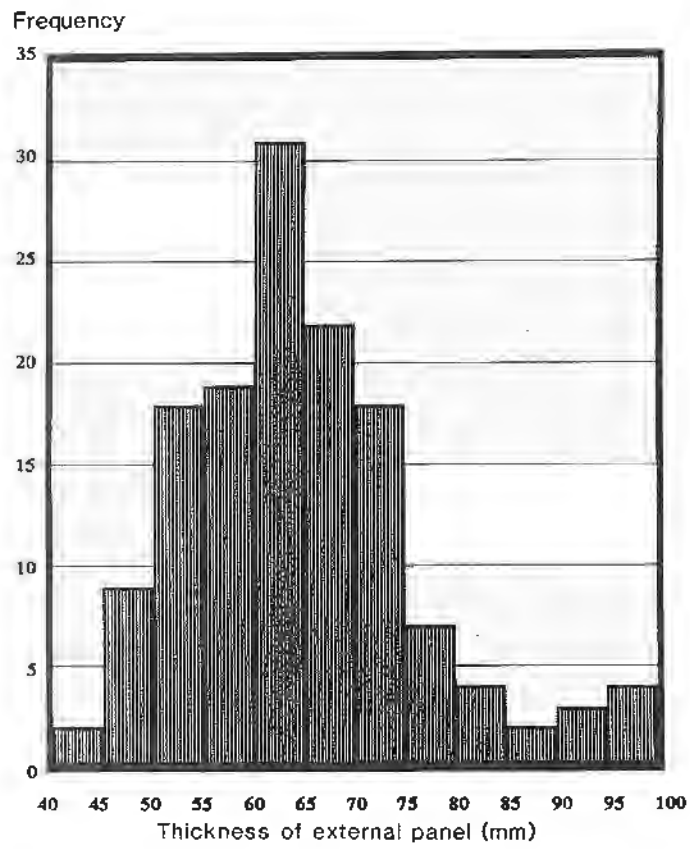
If we compare the measured maximum covers with the thicknesses of the external panels (Fig. 10), it can be seen that the reinforcing bars (especially at the edges of the panels and the vertical bar of the supporting lattice) can be very close to the inner surface of the panel.

Fig. 10. Distribution of measured thicknesses of external panels.
