MORTAR LININGS IN DUCTILE IRON PIPES.

Inger Meland, Research Engineer, SINTEF Structure and Concrete,
N - 7034 TRONDHEIM, Norway.

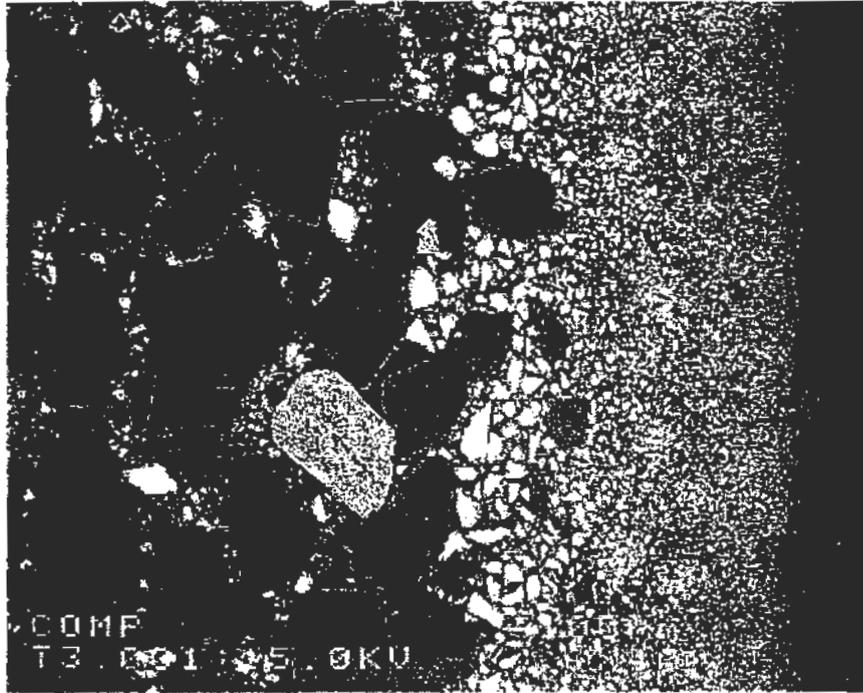
Figure 2 Cross section of lining produced by rotating the pipe over a fixed centrifugal head, (steel to the left side).

The examination of the mortar linings showed that all 15 pipes included in the project had been lined by rotating the pipes while passing them over a fixed centrifugal head. As mentioned earlier, this results in a segregation of the mortar, giving a cement rich layer with low w/c-ratio at the water side (see example in Figure 2)

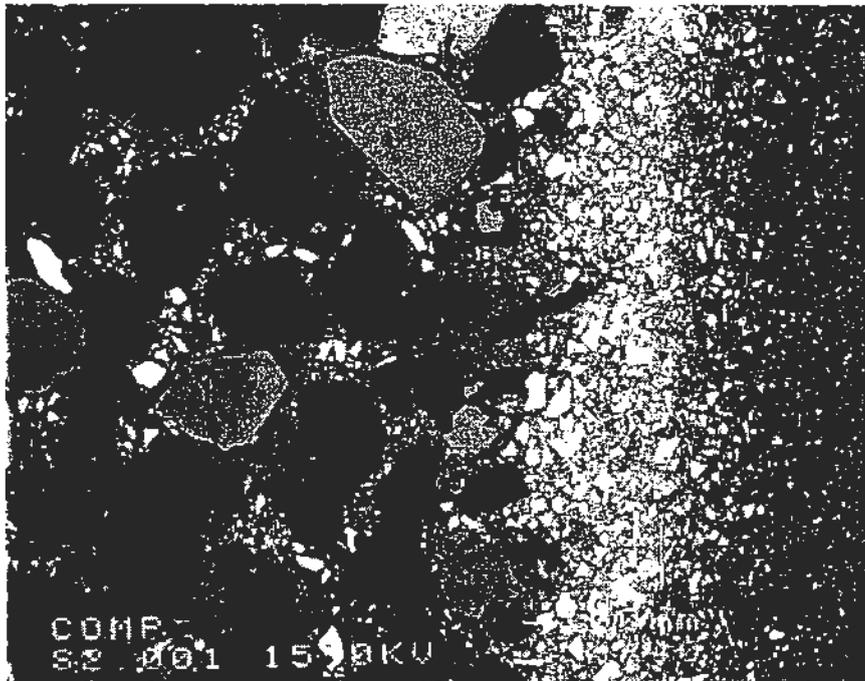
Results from the SEM (BSE) examination of one of the specimens are shown on Figure 3. The photo shows a cross section through parts of a mortar lining. The water side of the lining is shown at the right hand side on the photo. Dark areas on the water side show leaching of material from the paste. The corresponding EDAX results are shown on Figure 4, and from this figure it can be seen that calcium (Ca²⁺) has been leached from the cement paste to a depth of about 0.5 mm, which confirms the SEM-examination with respect to depth of leaching. This mortar lining had been exposed to water No 4 (See Table 1) for about 23 years, and turned out to be among the better ones in this investigation.

Figure 3 SEM (BSE) showing cross section of mortar lining. The water side is shown to the right on the photo. Dark areas at the water side mean a more porous i. e. leached cement paste. Magnf.: 40 X.

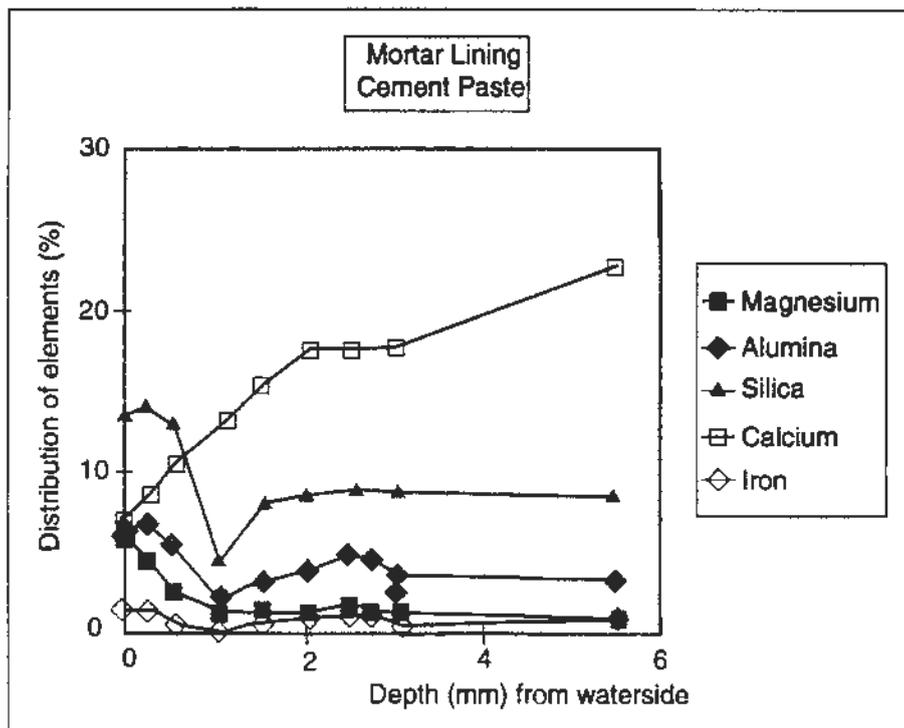
Figure 4 Distribution of elements (%) through the mortar lining.

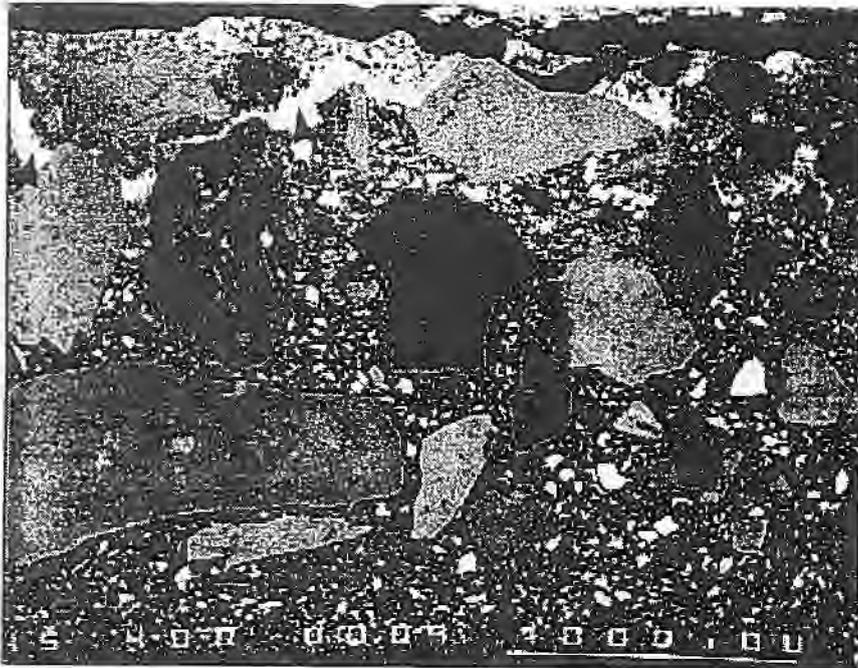
Some of the pipes investigated also showed a considerably reduced thickness of the mortar lining, which means contamination of drinking water and a dramatically reduced capacity to protect the iron pipe against corrosion. A few of the pipes investigated had only 2 mm thick lining left. Figure 5 show the remaining mortar lining of a 20 years old pipe exposed to water No 3 (see Table 1). The cement rich layer on the water side (at the bottom of the photo) had been totally removed. Light areas at the iron pipe side, at the top of the photo, turned out to consist of iron, confirmed by EDAX (point analyses) indicated that the iron pipe had partly corroded. Figure 6 shows the distribution of elements in the remaining paste.

Figure 5 Leached 2 mm thick remaining mortar lining. Top side is next to iron. White areas marked with arrows indicate corrosion products which have penetrated into the mortar.

It is difficult to explain the great difference in disintegration between these two mortar linings. Both of them had been in use for about 20 years, and taking the water properties (see Table 1) into consideration, quite the contrary result should have been expected. However, circumstances which definitely will influence the durability of mortar linings are unknown. For instance,

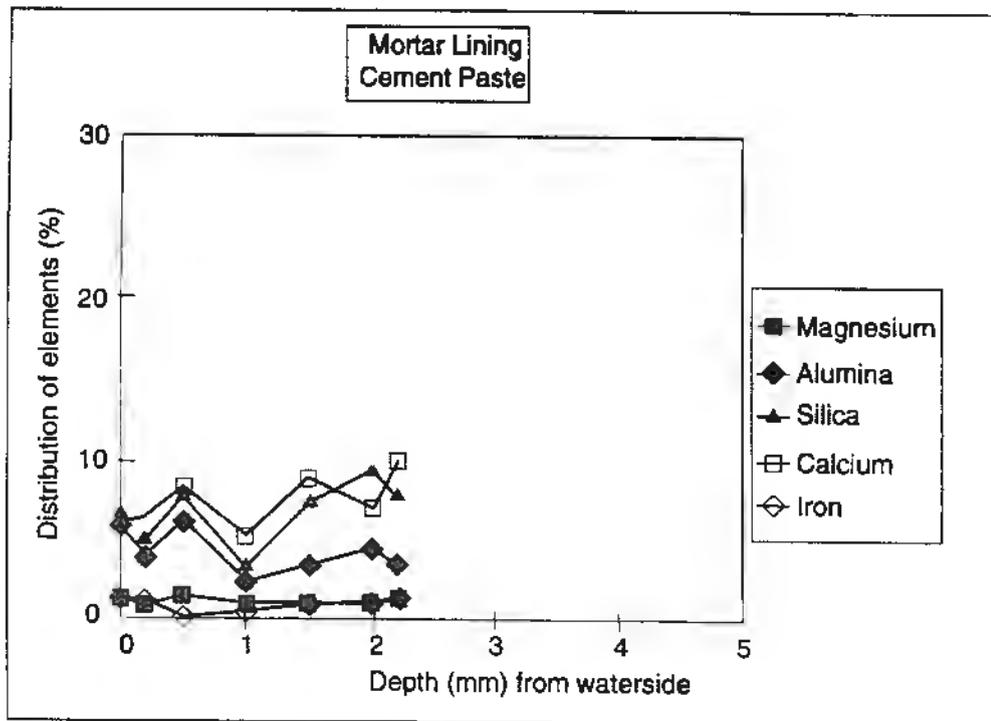
Figure 6 Distribution of elements (%) through the mortar lining.
