FATIGUE STRENGTH OF CABLE COUPLERS IN PRE-STRESSED CONCRETE BEAMS

Fatigue tests have been carried out on ten prestressed concrete beams. Six of the beams were furnished with a cable coupler in the mid-span and four beams had no cable coupler. The uncoupled beams could in some cases sustain 9 times as many load cycles as the coupled beams. Some probable causes to the coupled beams lower fatigue strength are discussed in the paper.

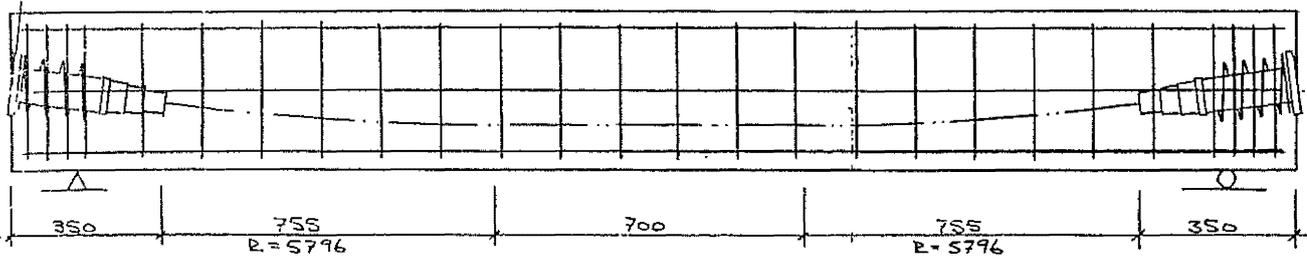
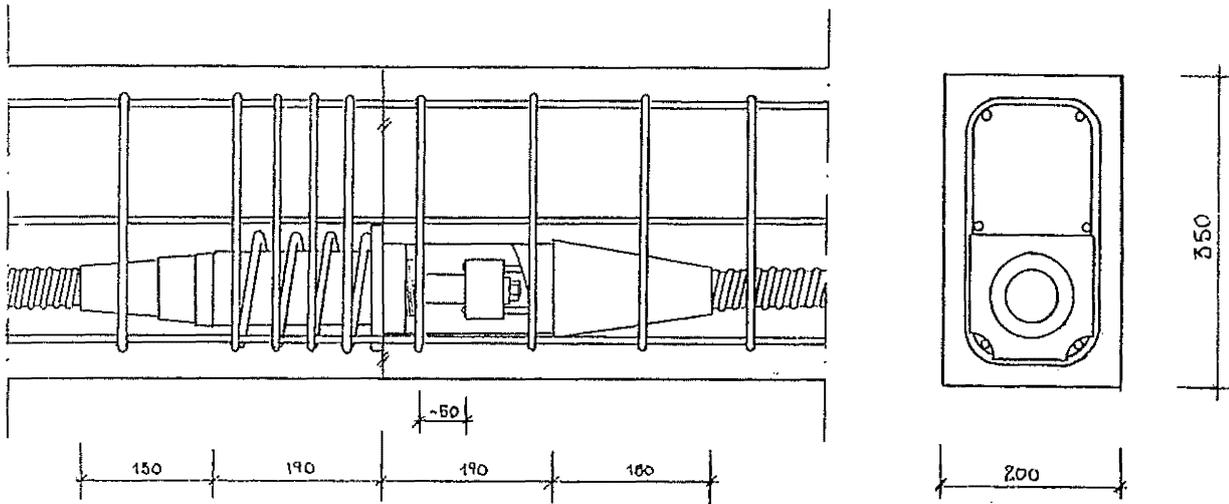
Fig. 1 Test beam

a) Reinforcement in an uncoupled beam

b) Detail over coupling section (BBRV coupler)

The test beams were designed with the objective of imitating the conditions in a prestressed bridge. In order to facilitate the testing the dimensions $2,90 \times 0,35 \times 0,20 \text{ m}^3$ were chosen, see Fig. 1. The concrete strength, f_{cc} , was chosen to 40 MPa. The non-tensioned reinforcement consisted of ribbed bars with the yield stress, $f_{yk} = 400 \text{ MPa}$. The longitudinal, non-tensioned reinforcement was not spliced in the construction joint.

The stressing of the tendons was performed with hydraulic jacks with due consideration to relaxation, friction losses, anchor losses and long-term losses. The left half of a coupled beam was concreted and prestressed two weeks before the right half (see Fig. 1.)

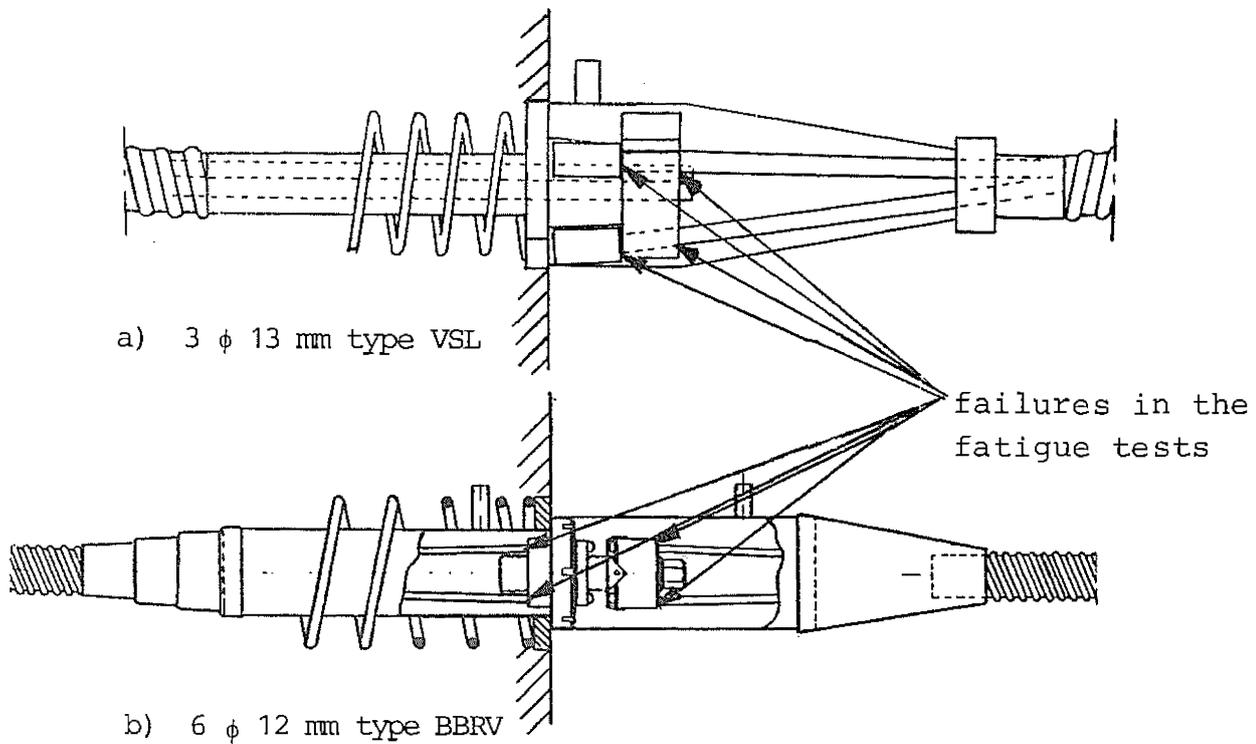
Fig. 2 Cable coupling units

Six of the beams had coupled tendons and a construction joint in the mid-span. The two investigated types of cable couplings are shown in Fig. 2.

The locations of the fractures in the cable coupling units are marked in Fig. 2. In Fig. 6 failures of wires and strands in VSL and BBRV couplers are shown. In the uncoupled beams the failures of strands or wires occurred close to the mid-span.

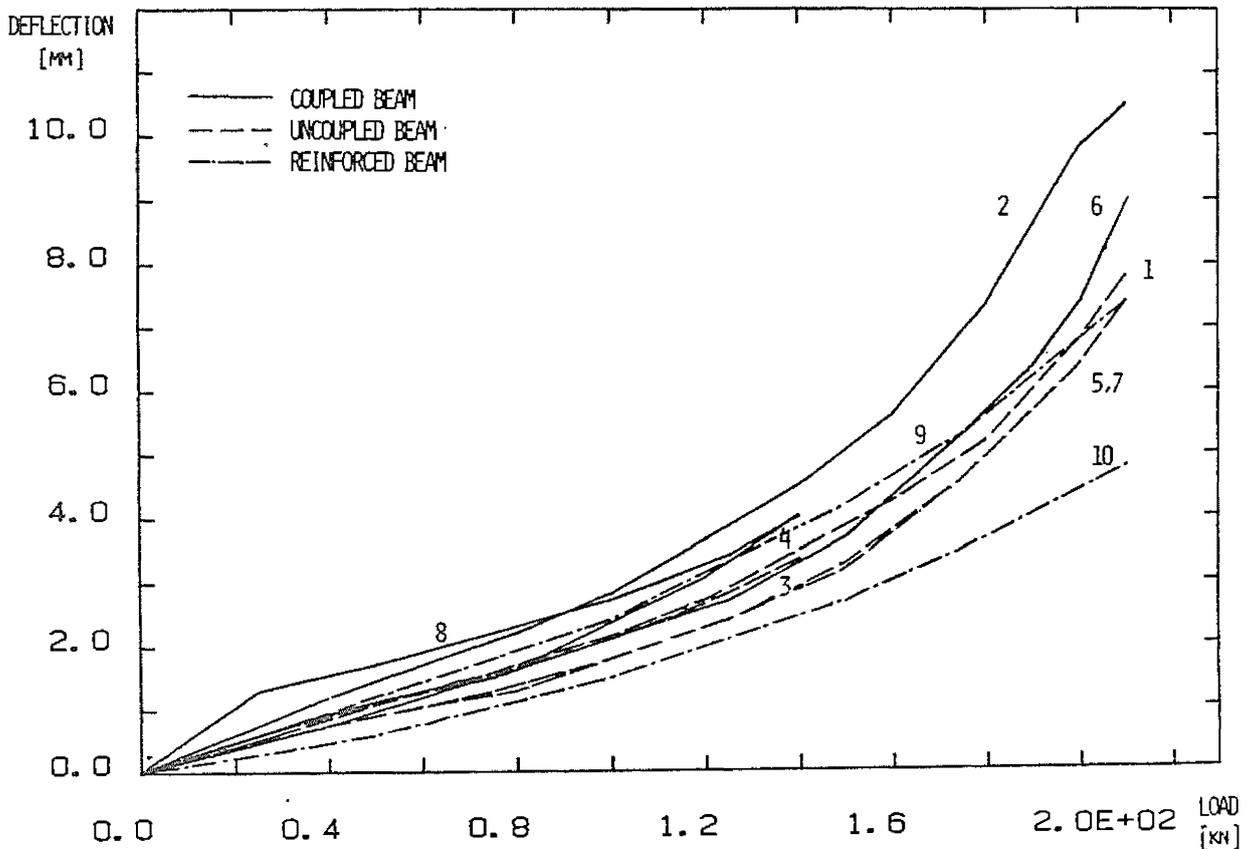
Fig. 4 Deflection-load curves at the monotonous loading to the upper load limit

In the stepwise loading, the uncoupled beams showed noticeably higher bending stiffness than the coupled beams. In Fig. 4 the deflection-load curves are plotted. From this figure it can be seen that the coupled beams display deflections up to 50 per cent larger than the uncoupled beams.

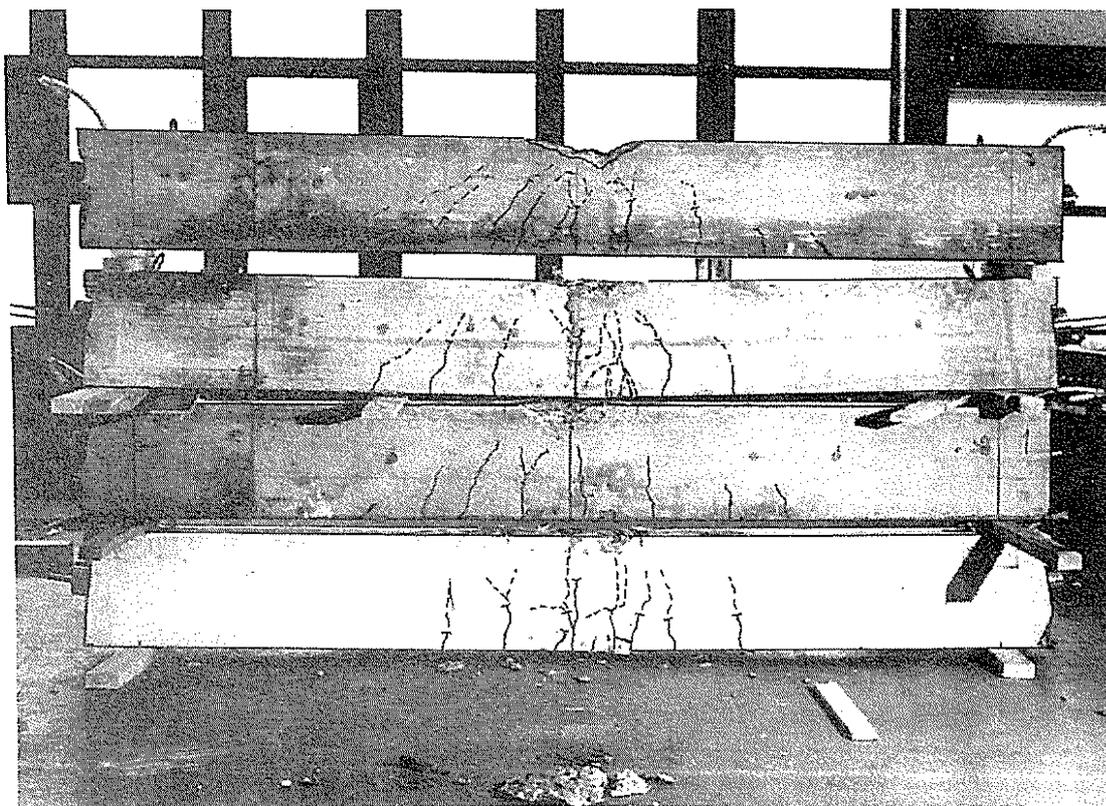
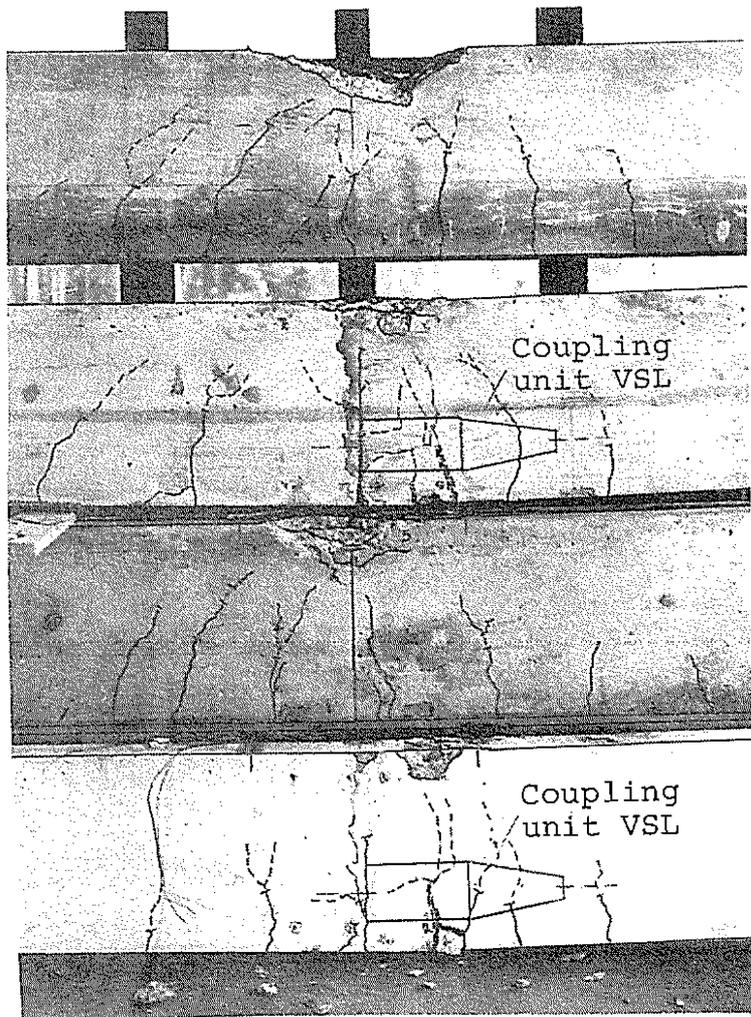
Fig. 5 Typical crack propagation of some tested beams

Under increasing load, cracks opened in the mid-span. In the uncoupled beams the cracks had a rather uniform distribution along the beam, see Fig. 5. The length of the cracks agreed rather well with the calculated length up to the neutral axis.

In the coupled beams the cracks were concentrated to the coupled section. In these beams the first cracks appeared for lower loads than in the uncoupled beams and the cracks overstepped the calculated location of the neutral axis.

The crack propagation in the fatigue tests is shown in Fig. 5. It can be seen that the propagation of cracks in the fatigue tests is concentrated to the area of the cable couplers.

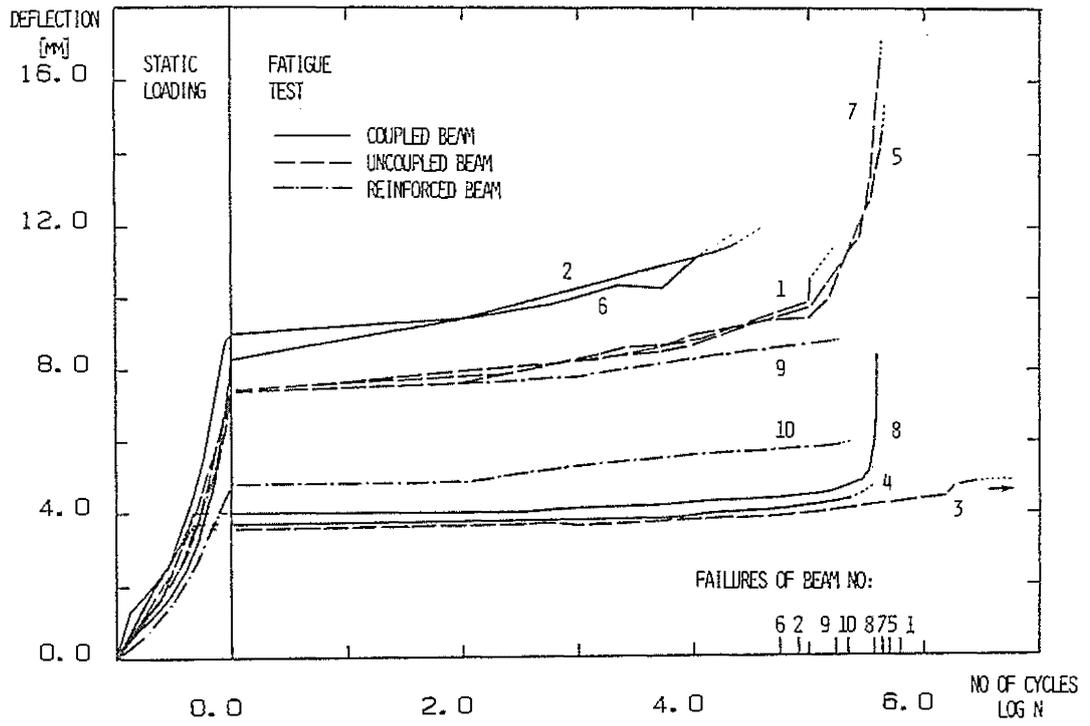
Fig. 7 Growth of the mid-span deflections in the fatigue tests

Figs. 7 and 8 show the growth of the mid-span deflection and the stresses in couplers. Although larger values, the deflections of the coupled beams showed similar growth compared to the uncoupled beams, see Fig. 7. The growth of mid-span deflection of the beams was very small in the beginning of the tests. In the last part of the tests the deflections increased markedly (see beam Nos. 5, 7, and 8). According to the growth of the stresses in the couplers, Fig. 8, a similar course can be seen. It is only in the last part of the tests where the stresses change. Especially for beam No. 8 the stress decreased markedly. This probably depends on failures of the strands.
