AN INVESTIGATION OF REINFORCED CONCRETE BEAMS IN TWO SPANS  
SUBJECTED TO FATIGUE LOAD

Robert Danewid  
Grad.Eng.  
Lund Institute of Technology  
Department of Structural Engineering

ABSTRACT

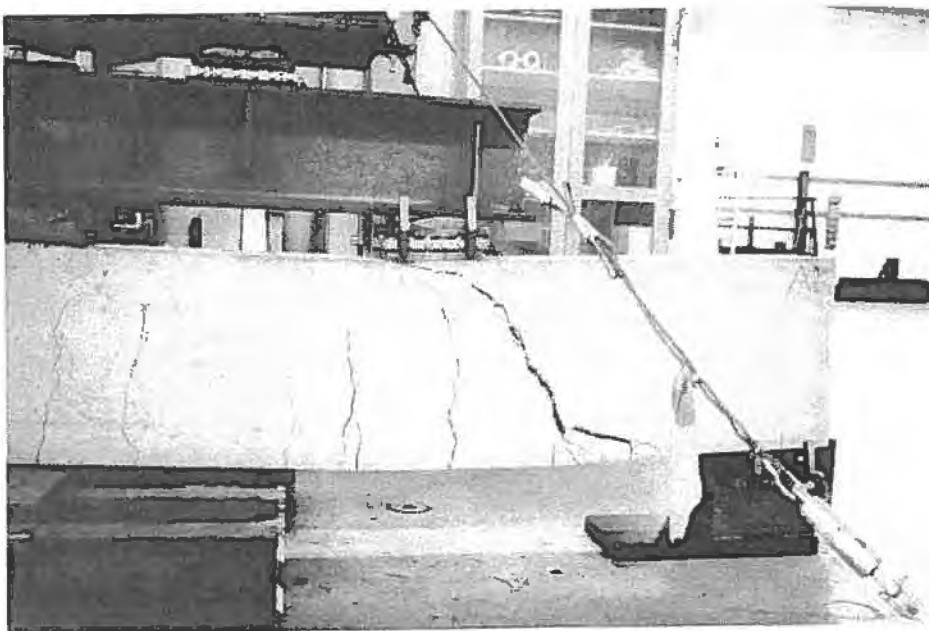
Photo 2. Shear failure in a non shear reinforced part of a beam.

- 1) Shear failure in a non shear reinforced part of a beam were recorded in three cases. See photo 2.
- 2) Shear failure in a shear reinforced part of a beam, but with no failure of the stirrups, was recorded in one case. See photo 3.
- 3) In one beam a shear crack originated at the outer support and was followed by bond failure in two of the four longitudinal bars. As a direct cause of this the compressive zone collapsed. See photo 4.
- 4) Failure of the stirrups at the middle support were recorded in two cases. The fractures were in both cases of a brittle nature. See photo 5.
- 5) In one case a brittle fracture was recorded in one of the four bars over the middle support. See photo 6. After a further 25 000 load cycles all the flexural reinforcement in one span failed. See photo 7.

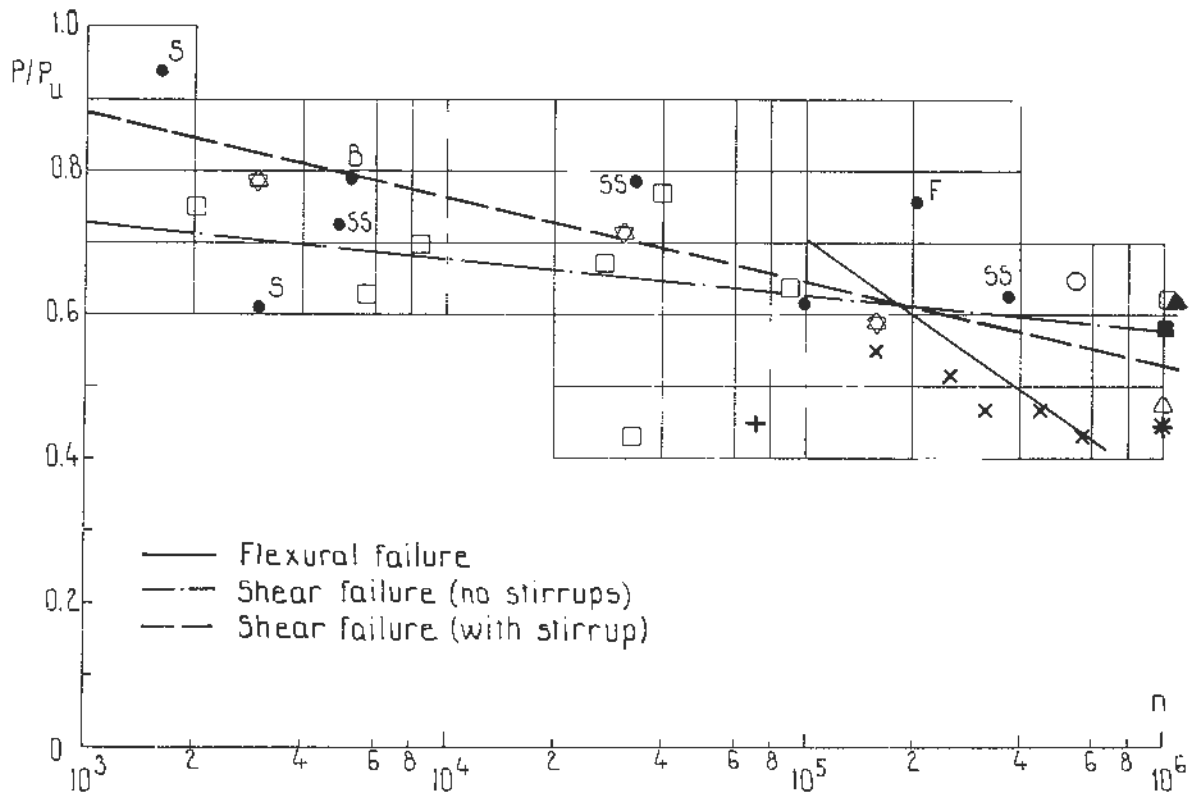
The results from this investigation and from some other investigations are presented in figure 7. The results are not quite comparable, as no regard has been paid to the lower load level. However,  $P_{\min}$  is less than 30 % of  $P_{\max}$  for all the presented results. Three lines of best fit are marked. One is for flexural failure, another for shear failure in a non shear reinforced part of a beam and the third for shear failure in a shear reinforced part of a beam. Figure 7 indicates that at high load levels (low number of load cycles to failure) it is fatigue of concrete which is the determining factor, while at low load levels (high number of load cycles) it is fatigue of the reinforcement which is the determining factor.

- Stelson & Cernica 1958      shear failure (no stirrup)
- Westerberg 1973              "              "
- △ Le Camus 1946                "              "
- Verna & Stelson 1963        "              "
- \* Le Camus 1946                shear failure (stirrup)
- ◉ Westerberg 1973              "              "
- × Westerberg 1973              flexural failure
- + Verna & Stelson 1963        bond failure
- Present investigation:
- S = shear failure (no stirrup)
- SS = shear failure (stirrup)
- F = flexural failure
- B = combined shear and bond failure

Figure 7. Comparison between the present investigation and some other.
