JOINTS AND DETAILS IN A PREFABRICATED COLUMN-SLAB SYSTEM - DESIGN BY TESTING

The development of a column - slab system for use in industrialized apartment buildings is in progress. Experimental testing is used to evaluate the strength and ductility of certain parts of the structure, for which ordinary strength calculations are considered unreliable or even impossible. The paper describes tests on different arrangements of horizontal ties in the floor connections, and tests on the shear capacity of the floor slabs.

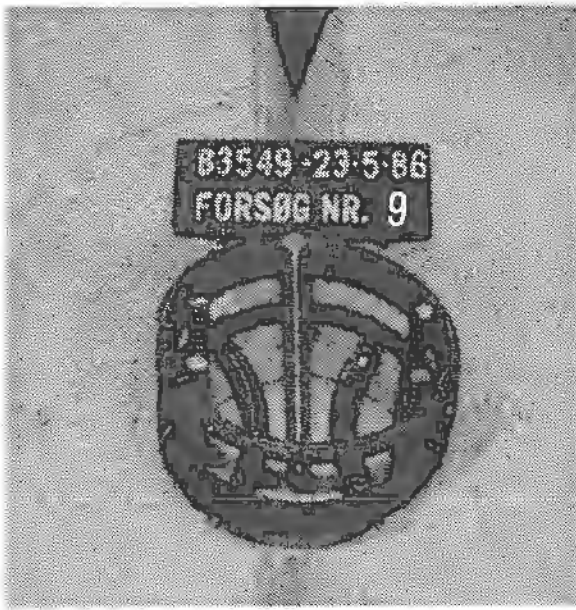
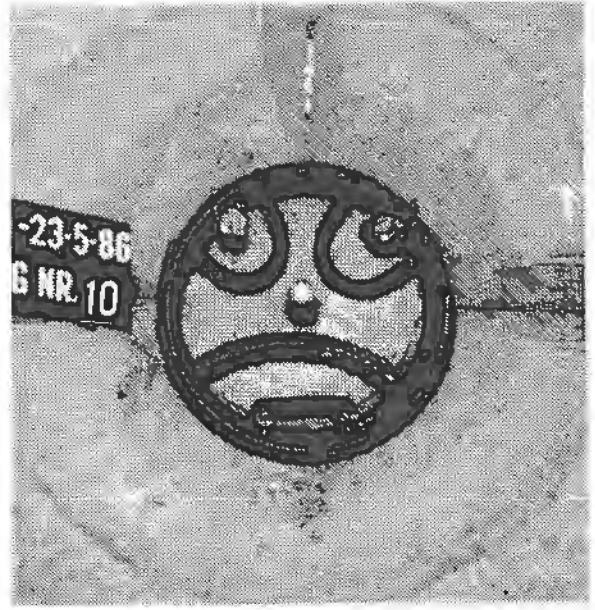
Figure 3: Examples of tie connection, showing protruding hair pins and reinforcement unit.

The specimen was loaded with a tensile force transferred to the ends of the slabs through anchored inserts. The force transfer in the joint was established by means of a protruding horizontal hair pin in each floor slab, a reinforcement unit connecting the two projecting hair pins, and the concrete in the joint. Figure 3 shows examples of the joint before the concrete is cast.

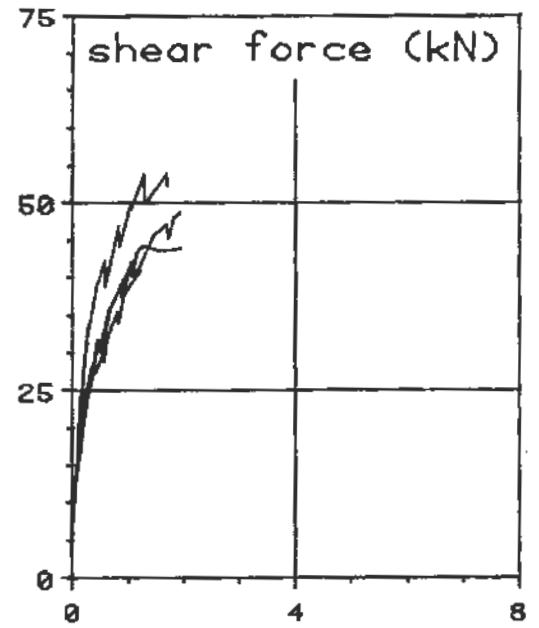
Figure 12: Load-deflection curves for shear tests 5-8.

The test results have been summarized in figures 10-13. Figure 10 gives the main results and figures 11-13 show the load deflection curves for each of the three slabs.

Tests 5-8 resulted largely in the same failure mode. The additional reinforcement, apparently, was not placed near enough to the edge of the slab and the shear failure could therefore still occur without being affected by the additional reinforcement to any appreciable extent.

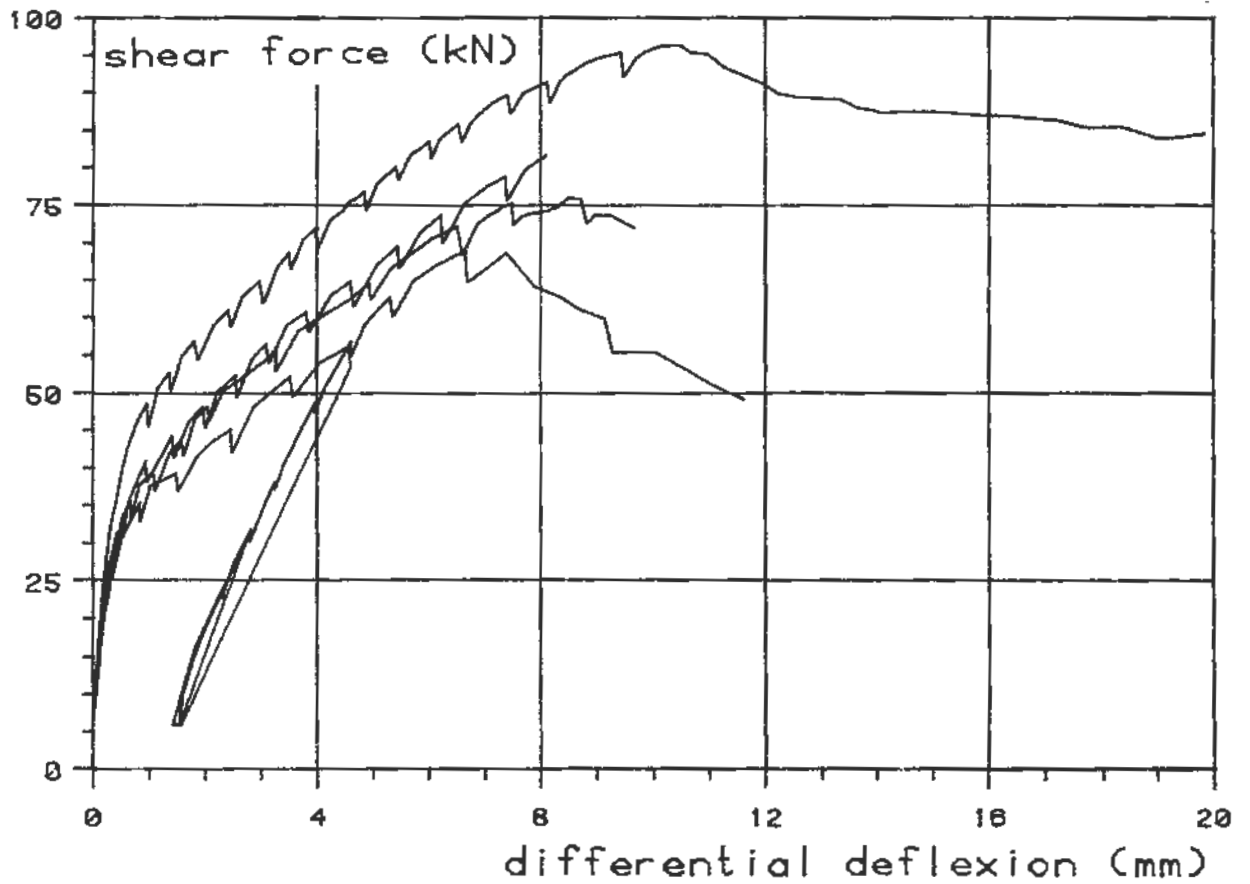
Figure 13: Load-deflection curves for shear tests 9-12

The details in tests 9-12 had been changed, that the additional reinforcement had no cover, and in some cases extra protruding reinforcement was provided. In test 11, a regular bending failure occurred in the slab, following the formation of shear cracks as in the other tests. Test 12 was identical to test 11 except that joint mortar had not been cast. Also in this case a substantial improvement of both strength and ductility was obtained. The strength was reached when the column in principle sheared off the exterior corner of the slab, so that the slab could move freely along the column. By this time the usual shear cracks had been formed. A comparison between tests 11 and 12 indicates that the joint concrete around the protruding hair pin restrains the movements which would otherwise result from a shear crack at the support. This restraint may explain the improved results in both tests 9, 10 and 11. In this context it should be mentioned that the shear strength in tests 11 and 12 is comparable to the punching shear strength to be expected in a corresponding, solid concrete slab supported on a circular column. A further improvement of the strength is not likely to be obtained.
