RESEARCH ON THE PARTIAL-INTERACTION
COMPOSITE BEAMS

Key-words: Composite beam, Studs, Shear connector, Partial-interaction, Shear capacity, Crack

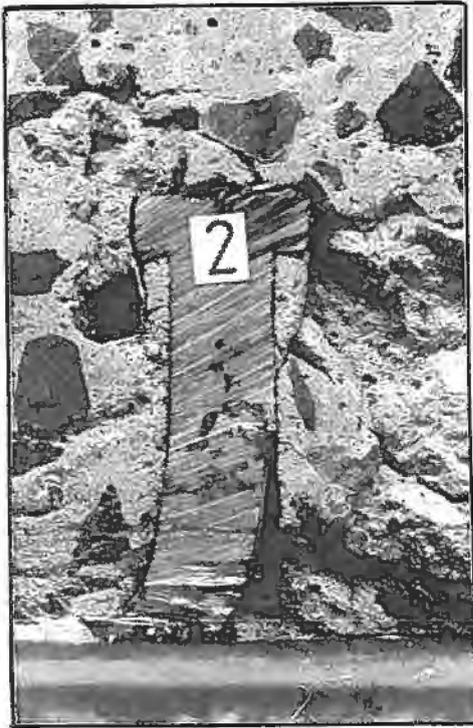
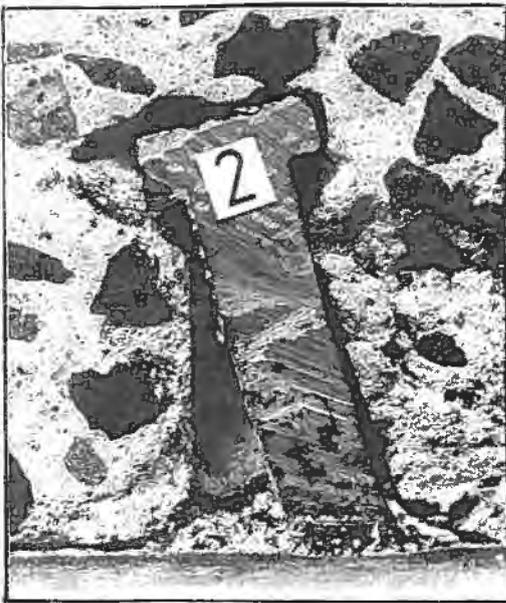
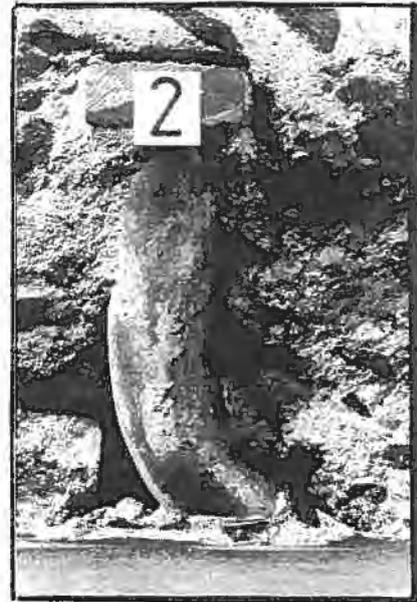
FIG. 7 Deformation of Studs

The deformation of the second stud from the end is shown in FIG. 7(a)-(d) for each of the four tests. The deformed shape of the stud is similar to that illustrated by the other researchers /4/, but with large deformation. Such large deformation in the shank near the base of the stud shows that rather great horizontal shear force was taken by the shank of the stud. FIG. 8 illustrates the deformed shapes of the first three studs which were fractured in the test in specimen 1BF. The studs with apparent permanent deformation broke not only at the interface between the shank and the welded collar, but also at the deformed shank.

The deformed shape of the studs was different in 1AS, as shown in FIG. 7(c). The studs were almost straight but rotated an angle about 17 degrees from the vertical position. Probably the longitudinal crack at the base of the studs started early and propagated quickly due to the absence of transverse reinforcement. Therefore the concrete surrounding the stud lost its strength. It was apparent that the concrete in front of the stud in 1AS was crushed and that the concrete was much more damaged than in other specimens. The observed behaviour shows that transverse reinforcement around the studs not only took horizontal shear force but also improved the whole situation of the concrete in the vicinity of the connectors and prevented local failure which could have resulted in beam failure. The effect of transverse reinforcement on the strength and failure mechanism needs more experimental and theoretical work.
