FULL SCALE SHEAR TESTS ON MODERN HIGHWAY CONCRETE BRIDGES

Full-scale shear tests were performed on two
concrete highway bridges constructed in 1980.

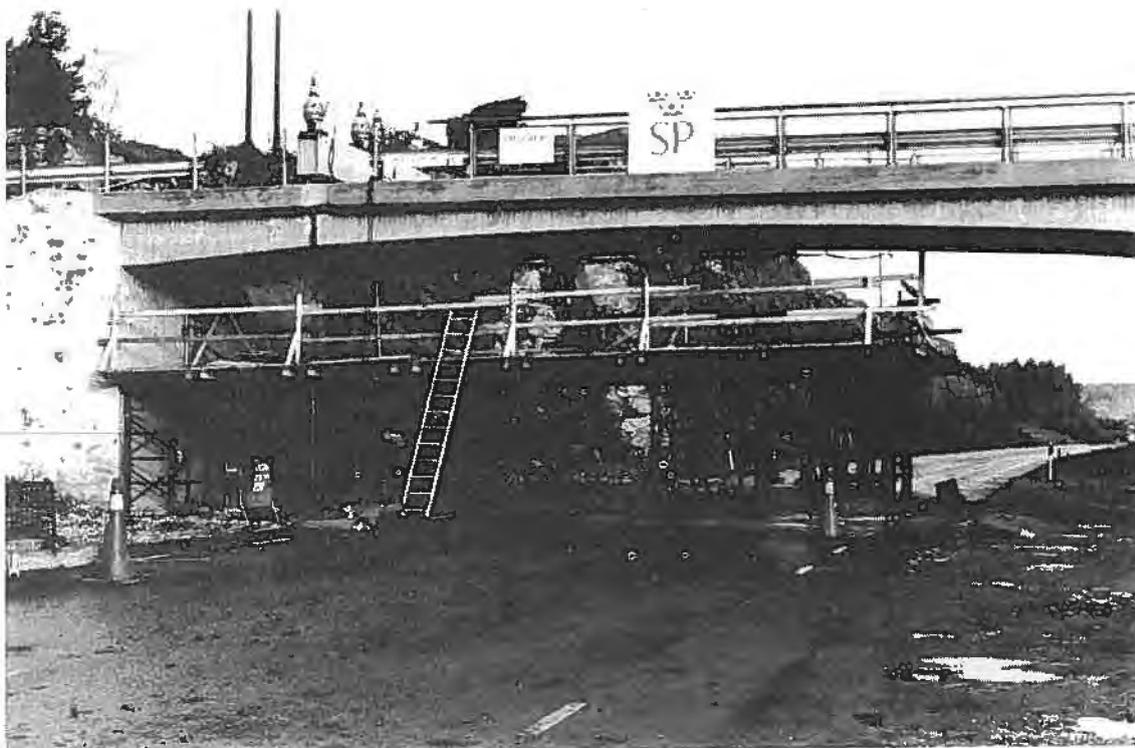
Fig. 1. Non-prestressed bridge during test preparation.

Full-scale shear tests were performed on two concrete portal frame bridges. One of the bridges was a non-prestressed slab frame bridge with a free span of 21 m (fig 1 and 2). The depth of the slab varied from 1.15 m at the supports to 0.65 m at midspan. The main reinforcement in the bridge slab was of the quality Ks 600, while the secondary reinforcement was of the

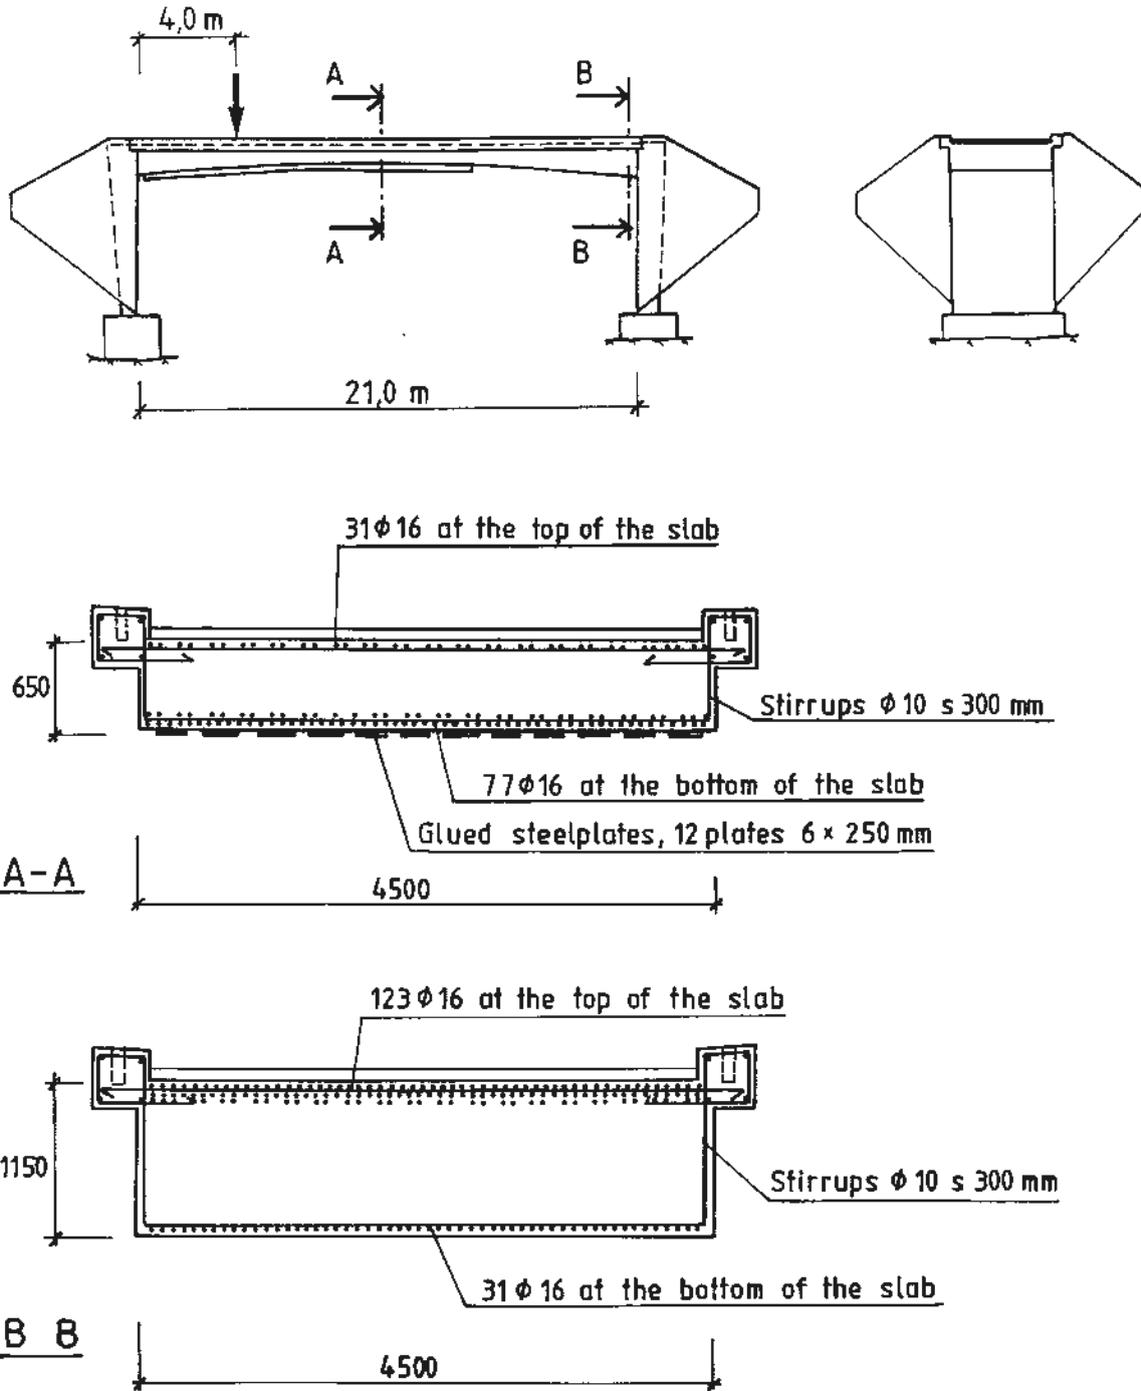
Fig. 2. Non-prestressed bridge

quality Ks 400. In the original design of the bridge the reinforcement was anchored with respect to the bending moment due to vehicle loads. In the test, however, the bridge had a different moment distribution, and to make shear failure possible the moment capacity of the bridge was increased by longitudinal steel plates glued to the underside of the bridge slab.

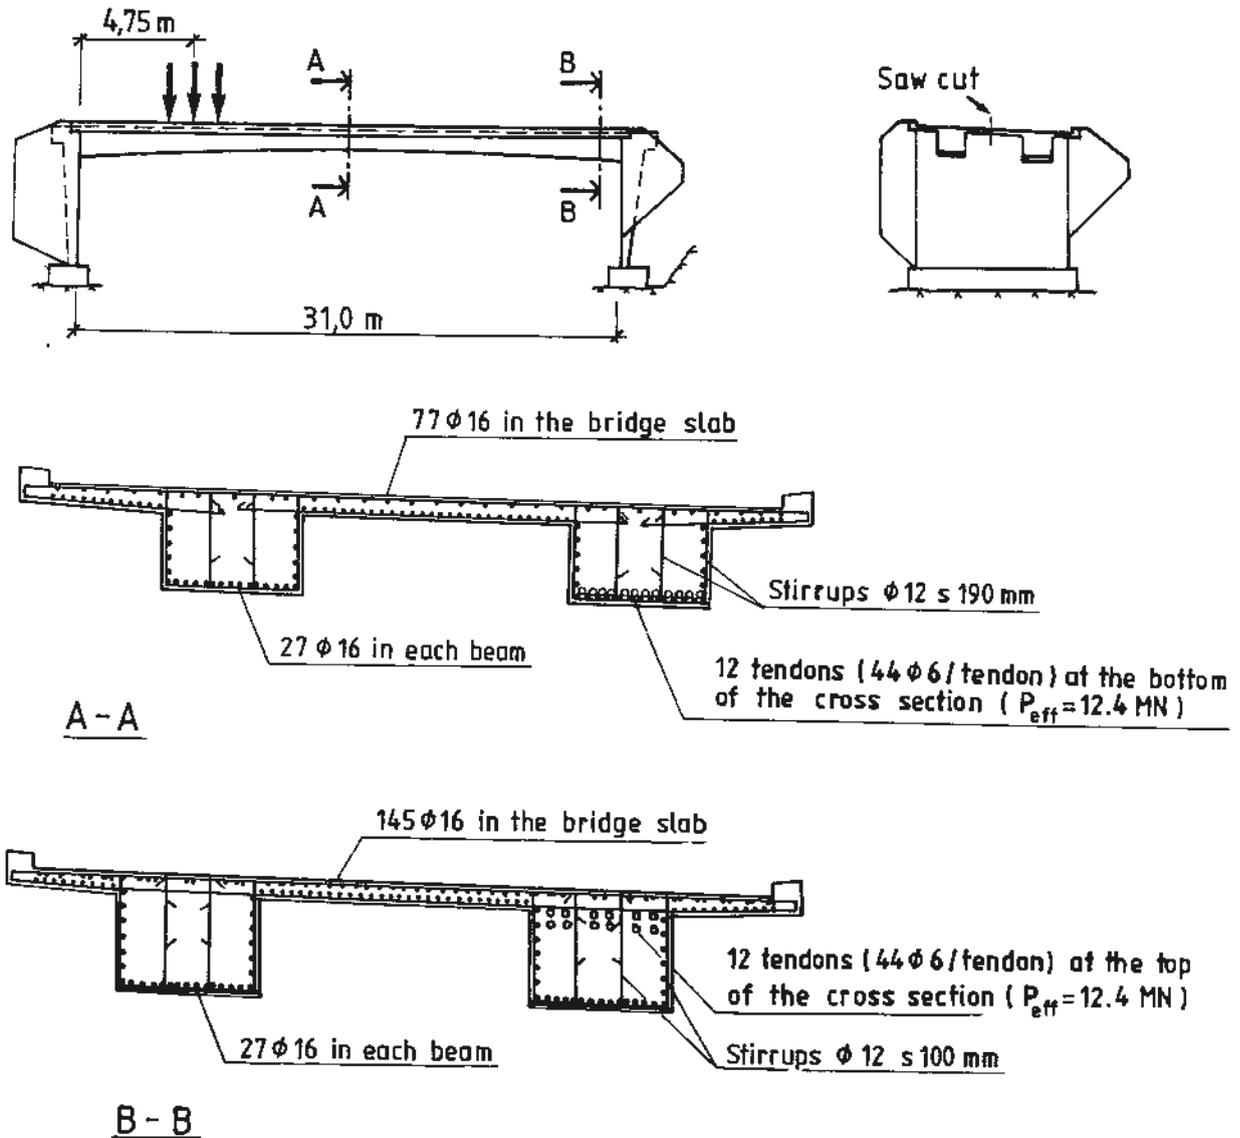
Fig. 3. Prestressed bridge

(fig 3 and 4). The span consisted of two post-tensioned beams connected by a bridge deck slab. The beams and the slab were connected to the front walls at the supports, forming a frame. The bridge beams had varying depths, 1.64 m at the supports and 1.16 m at midspan. The prestressing reinforcement was of type BBRV and consisted of 12 tendons per beam. The tendons consisted of 44 wires, each of 6 mm diameter. The profile of the tendons was parabolic, so that they were located at the top of the cross-section at the supports and at the bottom at midspan. The mean effective prestressing force in each beam was calculated to $P_{eff} = 12.4$ MN. The bridge was also reinforced by non-prestressed deformed bars of quality Ks 600 in the longitudinal direction and by stirrups of quality Ks 400. Before the test, the bridge deck slab was cut longitudinally between the two main beams, and the test was performed on one beam only.

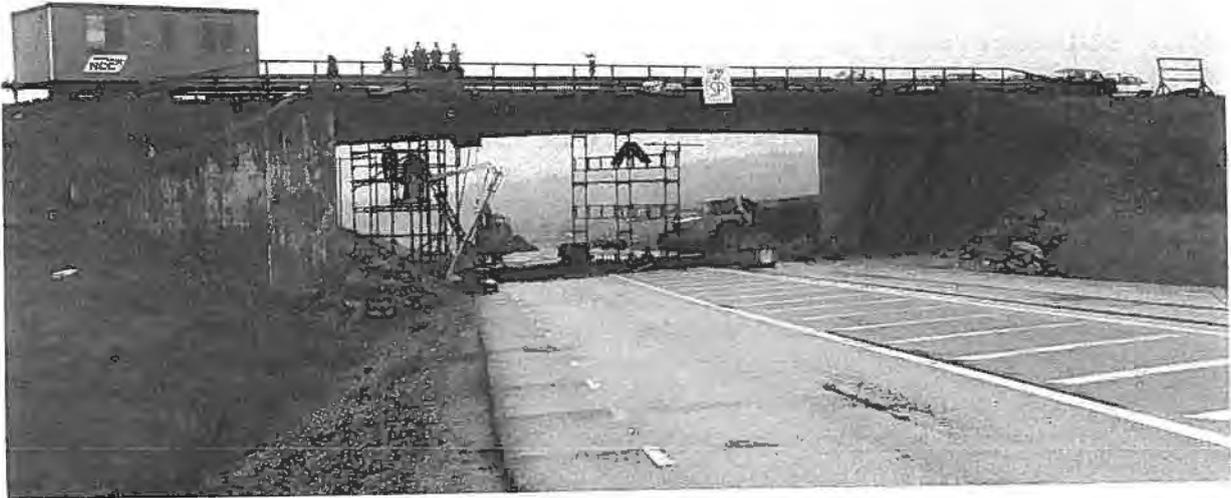
Fig. 4. View of the prestressed bridge

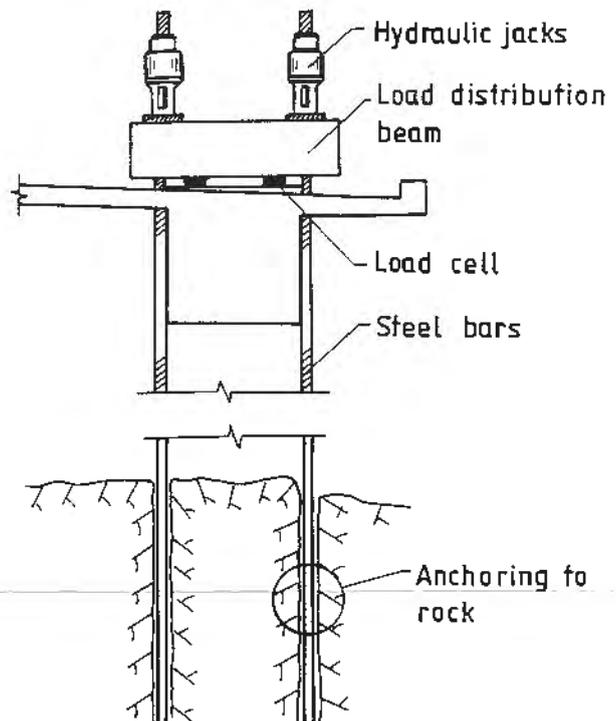
Fig. 5. Loading arrangement

The bridges were both loaded close to one of the supports to induce shear failure. The loads were applied through steel bars, placed in holes drilled through the bridges and anchored to the rock beneath (fig 5 and 6). The loads were transferred to the bridges by hydraulic jacks and load distribution beams, each beam placed between a pair of bars.

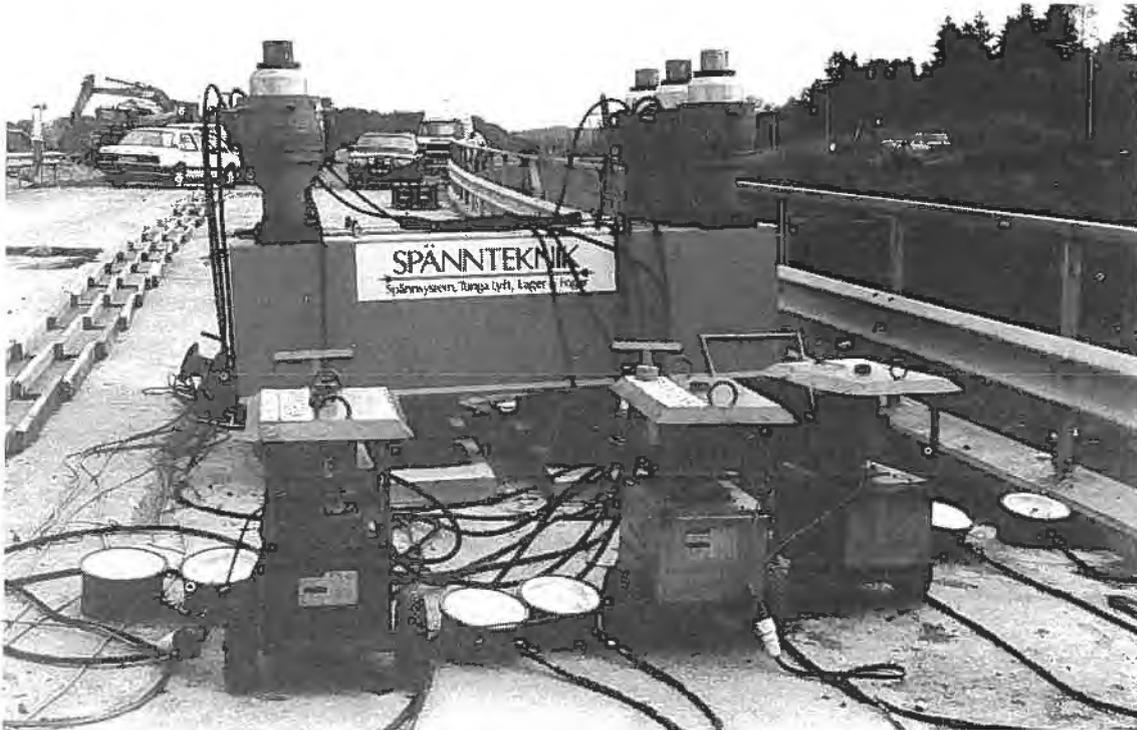
Fig. 6. Loading equipment on top of the prestressed bridge

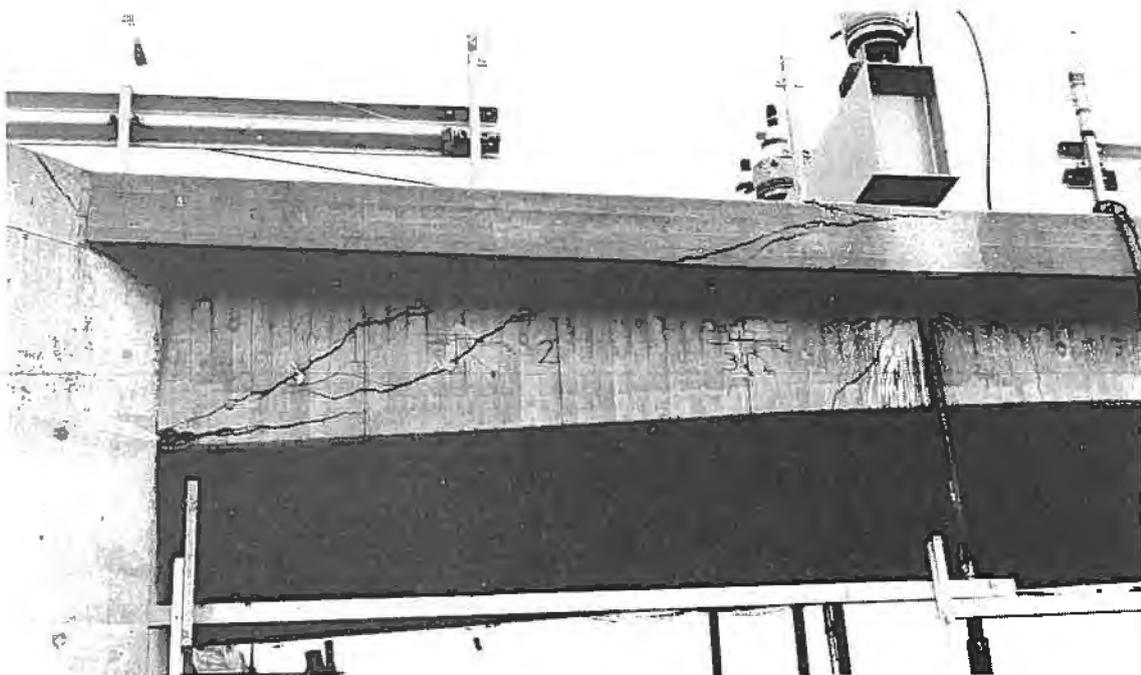
Fig. 7. Shear failure in the non-prestressed bridge

The non-prestressed bridge was loaded 4.00 m from one of the supports and failed at a load of 4.5 MN due to a sudden typical shear crack (fig 7). The load-deflection relations are shown in figure 8. The bridge was substantially cracked due to bending, and some shear-bending cracks were observed close to the loading section before the failure occurred. The shear failure was determined by a diagonal crack from the bottom of the cross-section at the support to the upper edge of the loading section.

In the non-prestressed bridge a typical shear failure occurred. The moment and shear distribution of this bridge are still under evaluation, but preliminary calculations show that agreement is good between the test results and the capacity according to the model in the codes. The shear force at failure was about 40 % higher than the characteristic shear capacity calculated using the Swedish Concrete Code, BBK 79, and measured material properties. This is a normal underestimation according to the comparison made by Hedman and Losberg /2/, where 1099 test beams were compared with the authors' proposal for BBK 79 concerning shear capacity.

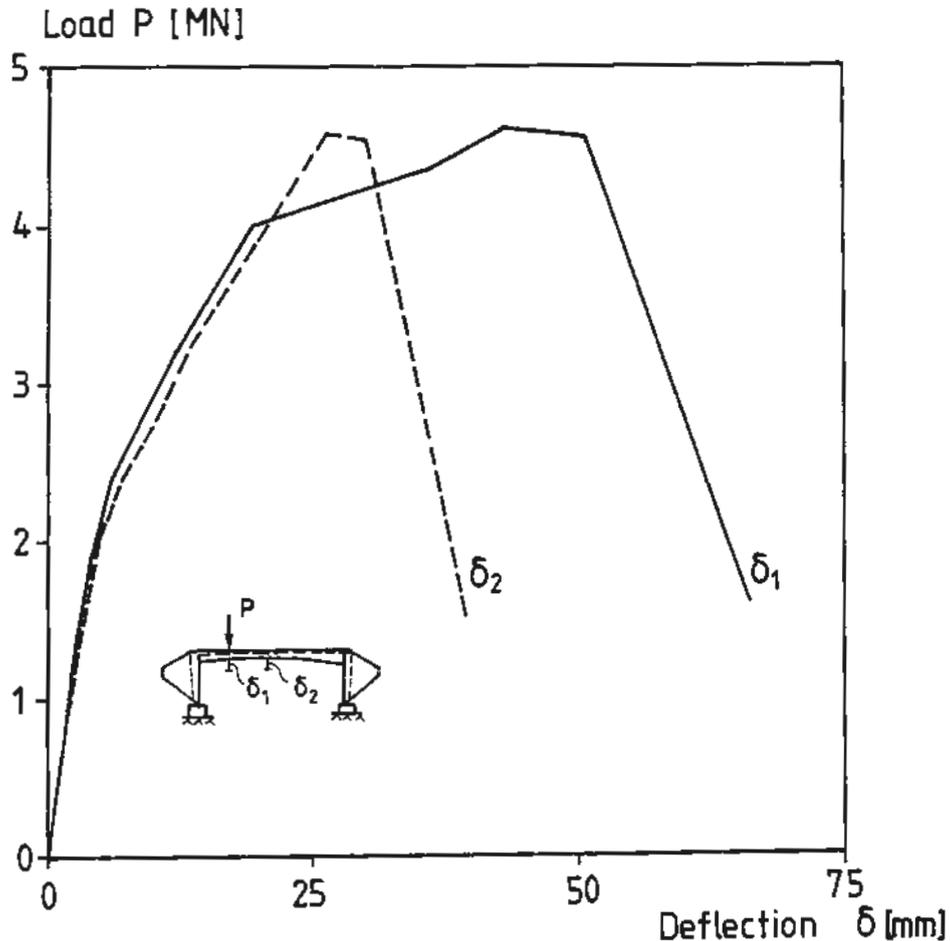
Fig. 8. Relation between load, P , and deflection, δ , for the non-prestressed bridge. δ_1 is the deflection of the loaded section and δ_2 is the deflection at midspan.

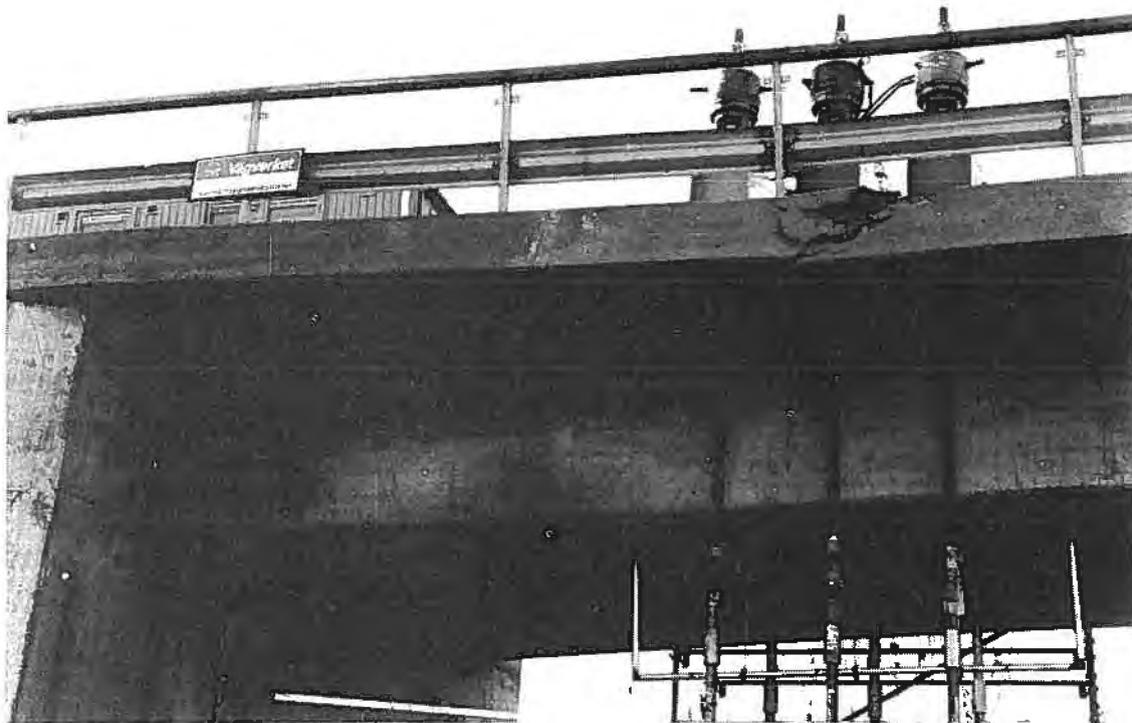
The prestressed bridge was cut longitudinally between the two main beams, and one of them was loaded with the load resultant acting 4.75 m from one of the supports in the same way as the non-prestressed bridge was. Failure was more complicated for this bridge. At a load of about 8 MN, extensive cracking due to bending together with some shear-bending cracks were observed. When the load reached 8.5 MN the support unexpectedly failed. The bottom part of the bridge beam moved into the front wall and the whole beam was displaced downwards. The support failure led to a redistribution of the moment as the degree of restraint

When the support failed, the load decreased to 6.0 MN. Further loading with the jacks led to large deformations, with only a minor increase of the load. The large deformations resulted in several inclined cracks in the shear span. The final failure occurred at a load of 6.3 MN when the concrete at the upper edge of the loading section crushed due to compression (fig 8). This failure is probably best explained as an interaction failure caused by simultaneous bending and shear. The load-deflection relations are shown in figure 10.

Fig. 9. Failure in the prestressed bridge. Cracking, support failure and concrete compression failure at the top of the loading section can be seen.

At the maximum load level the shear force in the bridge was almost the same as the characteristic shear capacity calculated using BBK 79. Shear cracks and decreasing stiffness close to maximum load level indicates that a shear failure probably would have appeared in the bridge beam for a load not much higher than the maximum if the support had not failed. This shows that the design model probably is capable of predicting the shear capacity for this case within the normal scatter according to /2/.

After the support failure the shear force decreased and the moment gradually increased until the final failure in the beam occurred. The effect of moment must therefore have a decisive influence on the failure.

The final failure in the prestressed bridge must be regarded as a result of the interaction between shear force and bending moment. The design models in the codes do not take this interaction into account. According to the design models in BBK 79 neither shear nor moment failure should appear when the final failure was achieved in the bridge beam. According to the design models both shear capacity and moment capacity, calculated as separate capacities, were higher than the shear and the moment in the bridge at final failure.

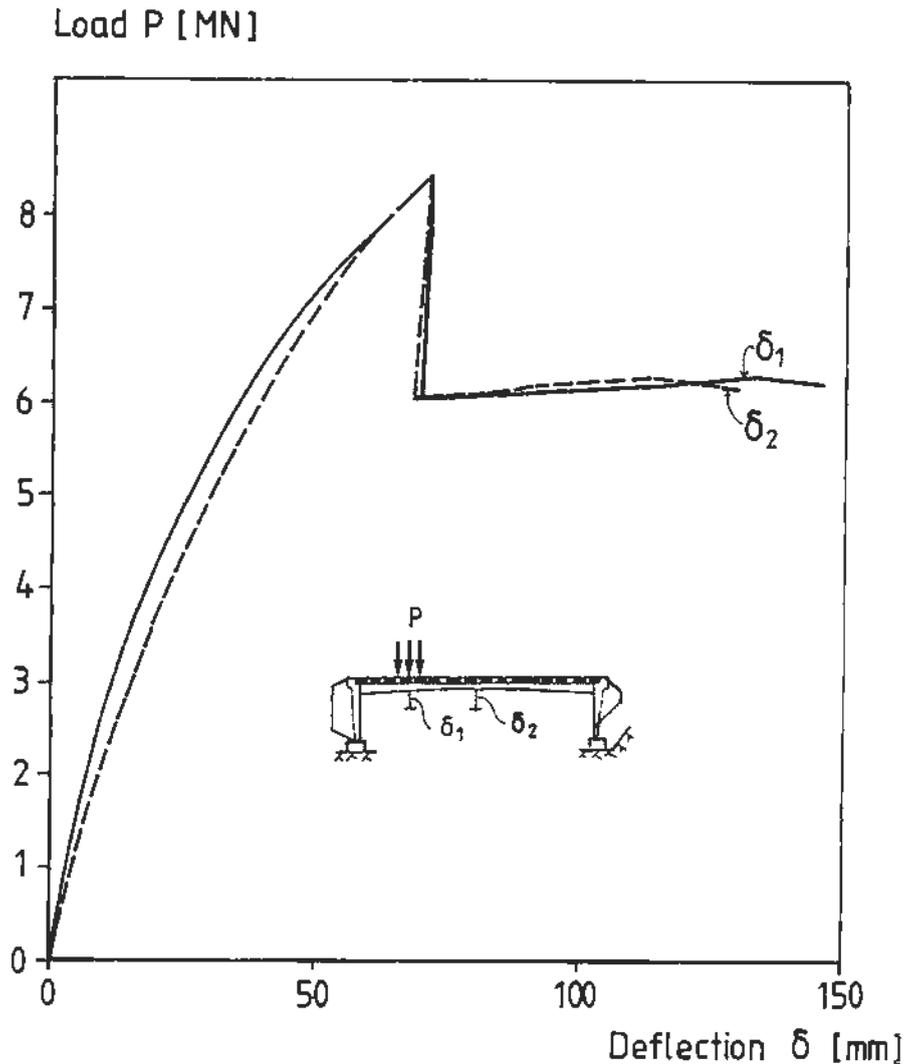
Fig. 10. Relation between load, P , and deflection, δ , for the prestressed bridge. δ_1 is the deflection of the loaded section and δ_2 is the deflection at midspan.
