Anchorage of Multilayered Reinforcement at Supports

Bent Steen Andreasen
 Ph.D., M.Sc, Engineer
 Rambøll & Hannemann A/S
 Bredevej 2
 DK - 2830 Virum, Denmark

This paper deals with a pilot test series with anchorage of ribbed reinforcing bars in more than one layer at a beam support. The specimens, the materials, the test set-up, the measuring instruments and the test results are described.

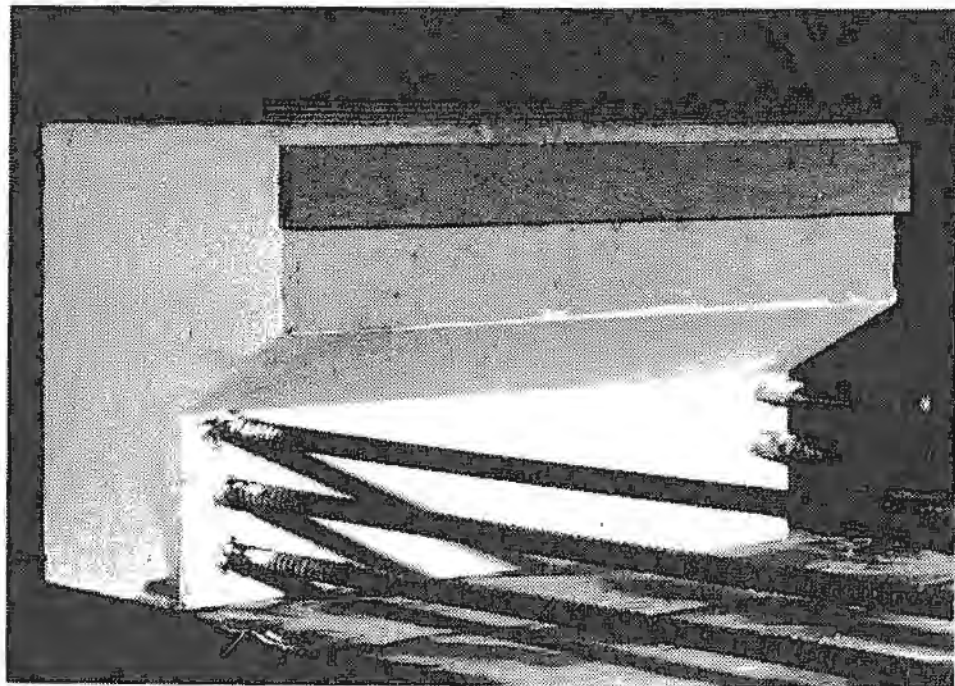
Figure 2: Type 2 specimen with 6 bars in 3 layers.

The specimens used in the tests are shown in figure 1. As can be seen from the figure, there are two different types of specimens. Type 1 with four bars in 2 layers, and type 2 with six bars in 3 layers. The bars are placed in the corners of the specimens, and the vertical distance between the bars is the same in all the tests. In figure 2 the type 2 specimen is illustrated.

The horizontal and vertical forces R_H and R_V were supported by 9 mm birch plywood plates, shown in figure 2. To ensure that only small horizontal forces were obtained at the vertical support, a teflon bearing was placed under the plywood plate.

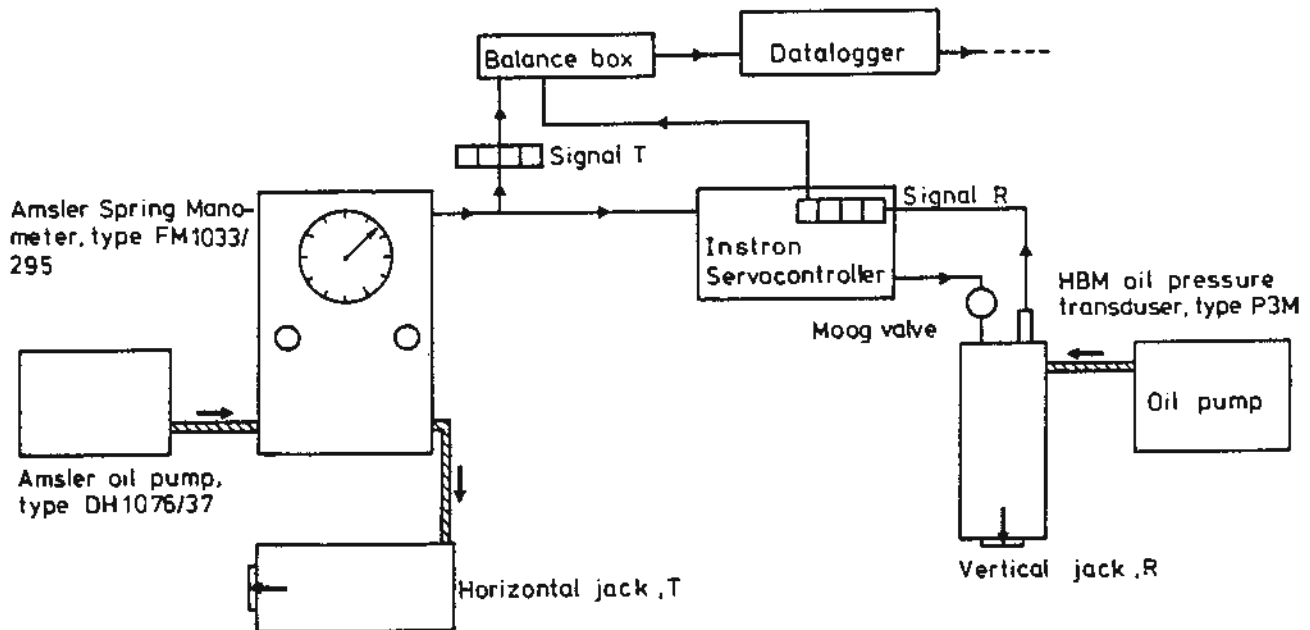
Figure 7: Diagram showing recording of signals from the vertical and horizontal forces, and control of the ratio between these two forces.

As mentioned in the preceding section the ratio between the vertical and the horizontal force, R/T , was kept constant during the test. The ratio was controlled by an servocontroller. A schematic diagram showing the registration of the signals from the vertical and horizontal forces and the control of the ratio between the forces is shown in figure 7.

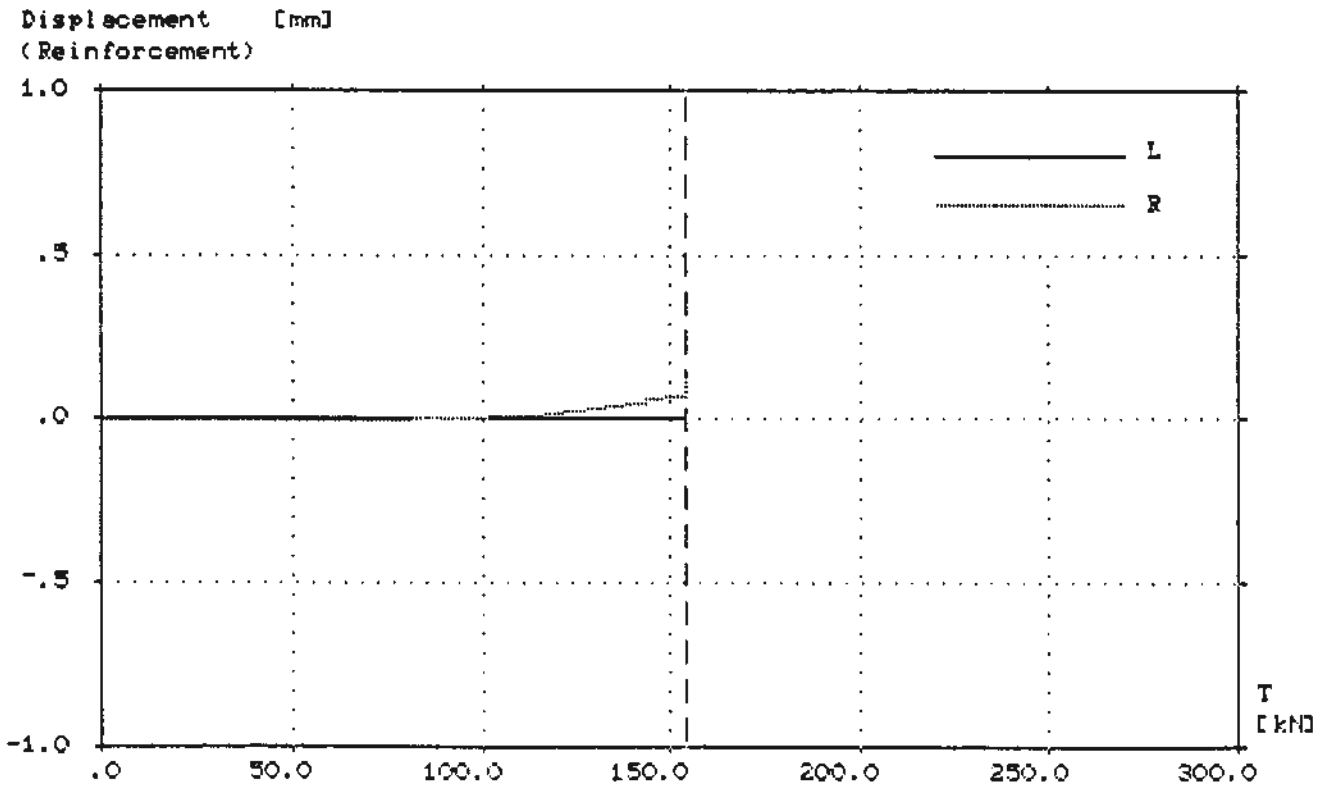
Figure 15: Free end slips as a function of the total horizontal force T in specimen No. 1-2.1.

The deformations of the specimen and the slip of the reinforcement as a function of the total horizontal force, using the symbols shown in figure 9, are given in figure 14 and figure 15.

The displacements of the test specimens are shown in figure 14 and 15. As can be seen in figure 14 there were some problems at the start of the tests, when the loads were small, which was a general problem. This corresponds to the discrepancy between the actual and the given ratios of R/T . When the load is increased the displacements in the different tests are in general similar. The displacements at the rear of the specimen, indicated by A, B, C and D, see figure 9, start at zero and increase linearly, and the inclination of the curves for the four points are identical, other things being equal. The problems at the beginning of the tests are probably caused by the previously mentioned discrepancy between the actual and the given ratios of R/T , and because the specimen settles down when the load begins to act on it. The displacements observed when the load is increased are, very likely, due to the compression of the plywood support plates. Perhaps a more stiff material should have been used, but after all, the displacements are small and apparently they cause no problems.

It seems that the measurement of the free end slip is acceptable in spite of the relatively simple method which is used (see section 5).
