**EXPERIENCE FROM NINE YEARS OF EXPOSURE OF
CONCRETE IN THE TIDAL/SPLASH ZONE**

Ten concrete blocks (1.5x1.5x0.5 m) have been exposed in the tidal/splash zone in the Trondheim fjord since 1983. Concrete parameters were concrete strength grade (C35 and C65 according to Norwegian Standard) and content of microsilica (0, 10 and 20 % as cement replacement).

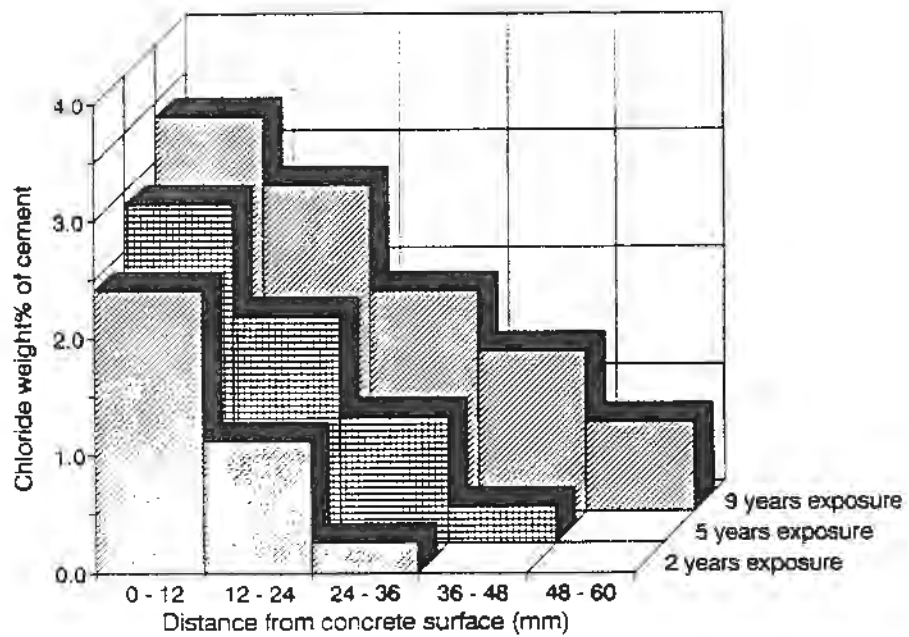
Fig 3 Average chloride profiles of C35 concrete with 20% MS

The results from the chloride analyses of the various concretes are given in Fig 1-5. Results from all three investigations are presented. The diagrams represent average values of samples taken from bottom and top of both the seaside and the landside. There was not found any significant influence of the position of the sample. In Fig 6-8 the results are reviewed according to exposure time.

The chloride analyses made after 9 years of exposure indicate a rather high initial (i.e. before exposure) chloride content of the concretes compared to the other investigations. This might be due to the in situ sampling technique used. Traces of chloride rich material from the surface of the concrete blocks might have contaminated samples from the inner of the concrete.

As expected, the chloride content has increased during the 9 years of exposure. The "surface" chloride contents of the C65 concretes have reached about the same level as the C35 concretes with MS. But the chloride contents of the C65 concretes are decreasing more rapidly with the distance from the surface into the concrete.

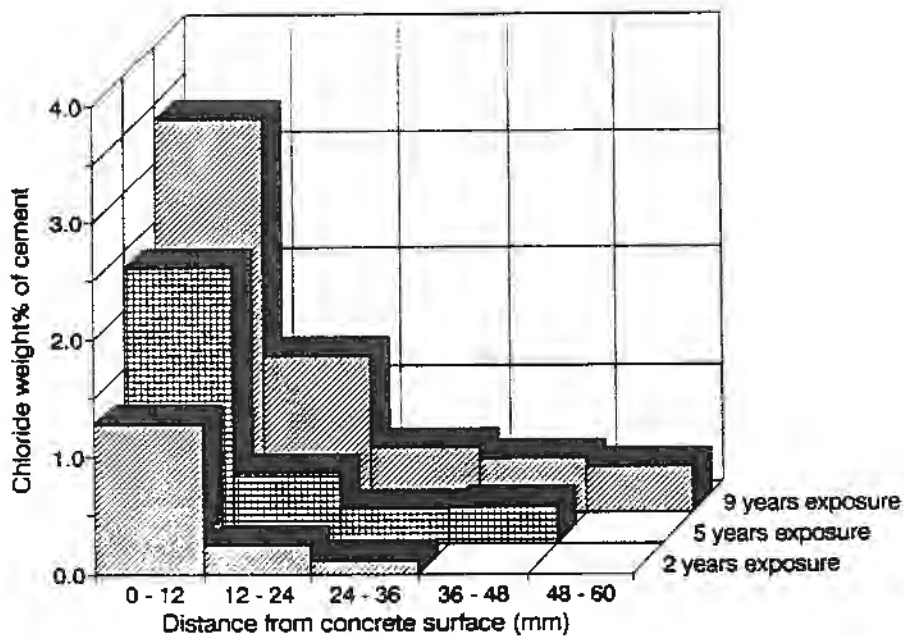
Fig 5 Average chloride profiles of C65 concrete with 20% MS
