SUBSEA REPAIR OF CONCRETE AND  
THE EFFECT OF FOULING

Division of Building Materials  
Chalmers University of Technology  
S-412 96 Göteborg, Sweden

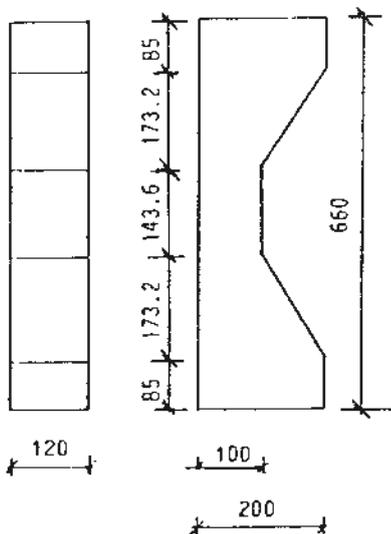
FIG 1. Measures of notched specimen

A concrete prism with a notch, FIG 1, was chosen as a test specimen for determining the bond strength between the old concrete and the repair material. The prism was subjected to axial compressive load until the bond was exhausted and the repair material was pressed out. Together with the notched specimens, others were casted without notches as well as Swedish standard concrete cubes and cylinders for determination of reference strengths.

The specimens used have been poured in three sets. Each set consists of 12 pieces with notches, FIG 1, 3 pieces without notches, 12 standard cubes  $0,15^3 \text{ m}^3$  and 3 standard cylinders.

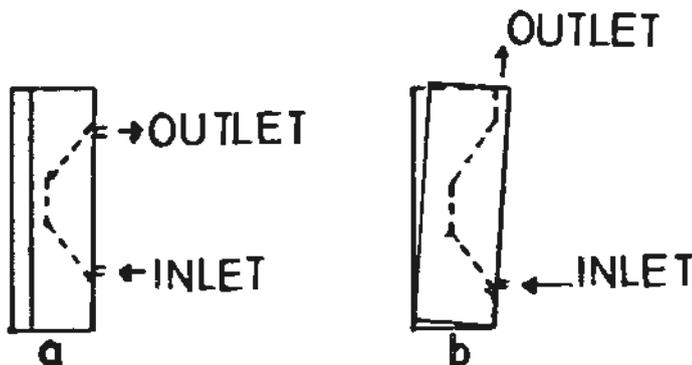
FIG 2. At injection the outlet was changed after day 1 from a to b.

At repair the notches in the specimens were filled with grout 10 m below sea level by injection. The outlet for the injected grout was changed, according to FIG 2. To increase the pressure in the repair grout the outlet was changed to position b. A repaired specimen is shown in FIG 3 after testing.

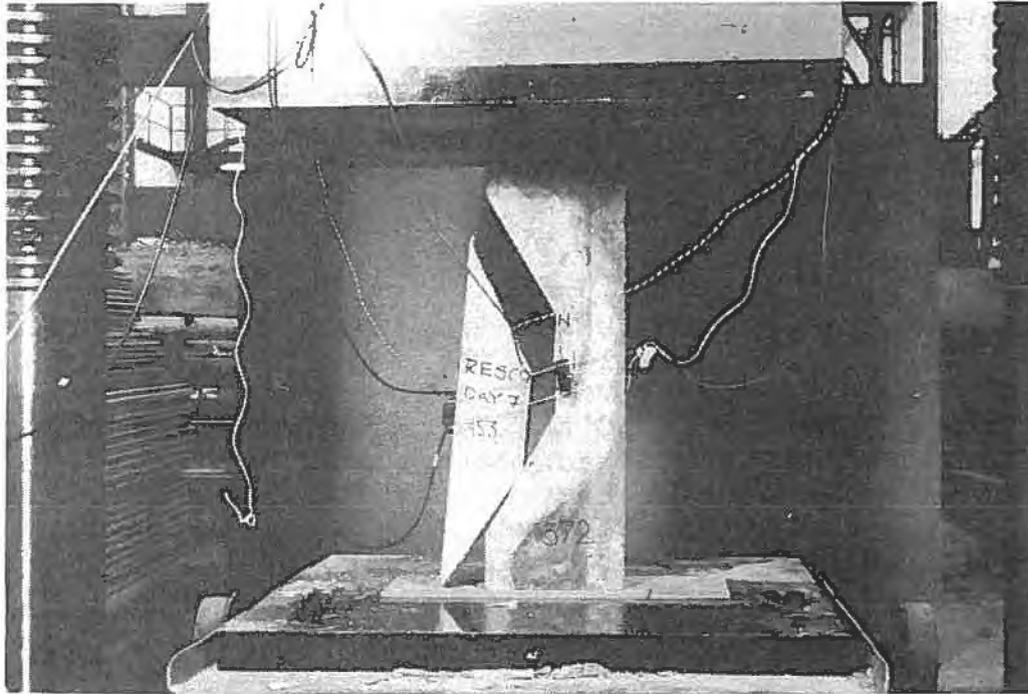
FIG 3. Specimen after test by axial compression

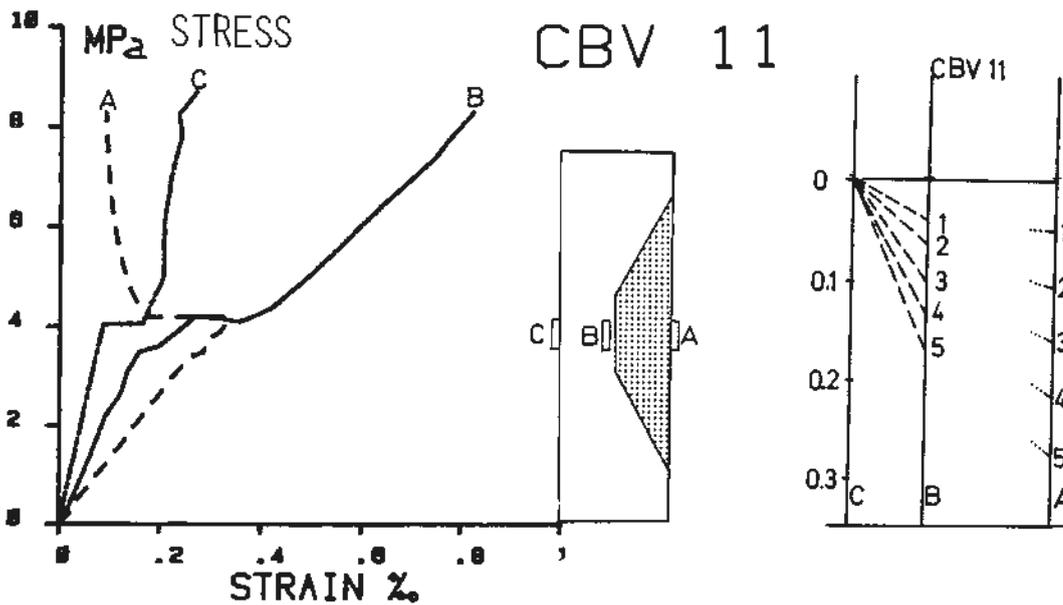
FIG 4. Stress-strain in specimen CBV 11

The determination of the bonding strength started one month after the repair work was finished and was performed by axial loading in a hydraulic 10 MN press and with strain gauges at four points, see FIG 4. The load was increased until the repair material broke out of the specimen at failure.

Results from a representative test can be seen in FIG 4. The graphs show the sequence of the testing procedure. The stress is calculated as the mean stress of the specimen, i.e. the load evenly distributed on the top area. The mean stress at ultimate bond failure is registered as a measure of the bonding strength.

The basic material has higher value of the modulus of elasticity and compression strength than the repair material. This may cause the situation that the stress-strain graph of the specimen will be influenced by internal excentricity, because of the dominating influence of the basic material, which partly hides the real qualities of the repair material. Deterioration of bond causes reduction of load in the repair material and corresponding load increase in the basic material.

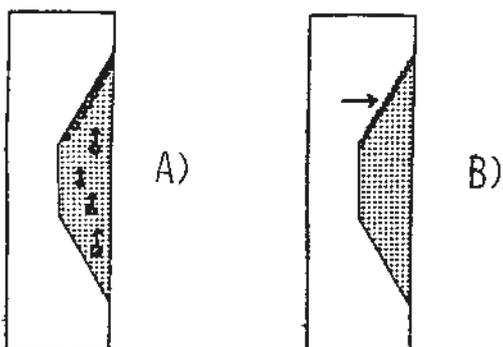
FIG 5. Concentration of air bubbles a) resulting in cracks b).

At testing cracks were observed in the upper interface between repair material and concrete, FIG 5. These cracks occurred on every specimen and in these cracks a white salt had been accumulated. This salt was analysed in a x-ray spectrograph and showed that ettringite was present among the salts. This ettringite has an expanding effect and is probably the reason for the widening of the cracks originally appearing as setting cracks. The cracks disturbed the determination of the bonding strength. However, if the disturbance is assumed to be the same for all specimens a comparison of the strengths of the specimens can be done. The strength represented by the mean ultimate compressive stress on the top area of the specimens are shown in FIG 6 at different times of repair. This strength is an indirect measure of the bonding strength.

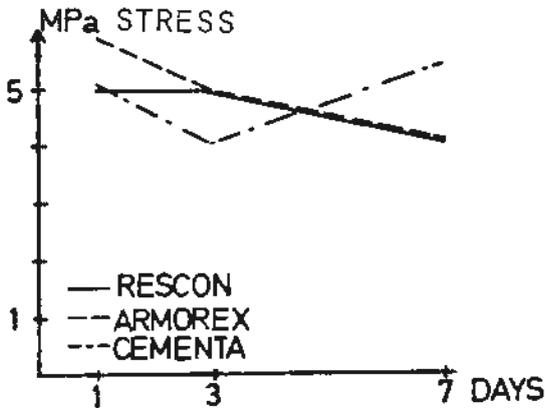
FIG 6. Average stress on specimens

The graph, FIG 6, shows that there is a change in the bonding strength between day 1 and day 7. Generally it is a decrease of the bonding strength except for the Cementa grout between day 3 and day 7. An explanation for this deviation is based upon the fact that at casting of the Cementa specimens the pump failed and the grout must be removed. It is possible that this procedure also removed the biofilm from the specimens. Therefore the regrouted Cementa specimens probably got a better bond.

The test procedure has shown that there is a decrease of the bonding strength. The decrease in bonding strength is 20 to 30% when the casting is done 7 days after the cleaning in comparison with if it is done immediately after it, FIG 6. If the casting is done 3 days after the repair the reduction in bond strength is about 10%. No influence of cleaning methods on bond was observed.
