EARTHQUAKE TESTS OF REINFORCED CONCRETE FRAMES

The paper presents a series of shaking table experiments performed at the Structural Laboratory at Aalborg University, Denmark during the autumn of 1996. The considered structure is a 2-bay, 6-storey reinforced concrete frame in scale 1:5. The test structure consists of two identical frames spaced 1000 mm on a shaking table. The dead-load of deck elements and pay load are modelled by 8 RC-beams placed on each storey in span between the two frames. One of the frames is instrumented with accelerometers at each storey and the shaking table is equipped with an accelerometer as well. Initially the modal parameters of the test structure are determined from a free decay test, where the top storey is pulled approximately 5 mm out from the equilibrium state. Afterwards the test structure is subjected to three strong ground motion oscillations where the two first sequences are followed by a free decay test. No free decay test was performed after the third earthquake due to collapse of the test structure during the third strong motion oscillation. After each of the strong motion sequences the structure is visually examined to reveal cracks etc.,

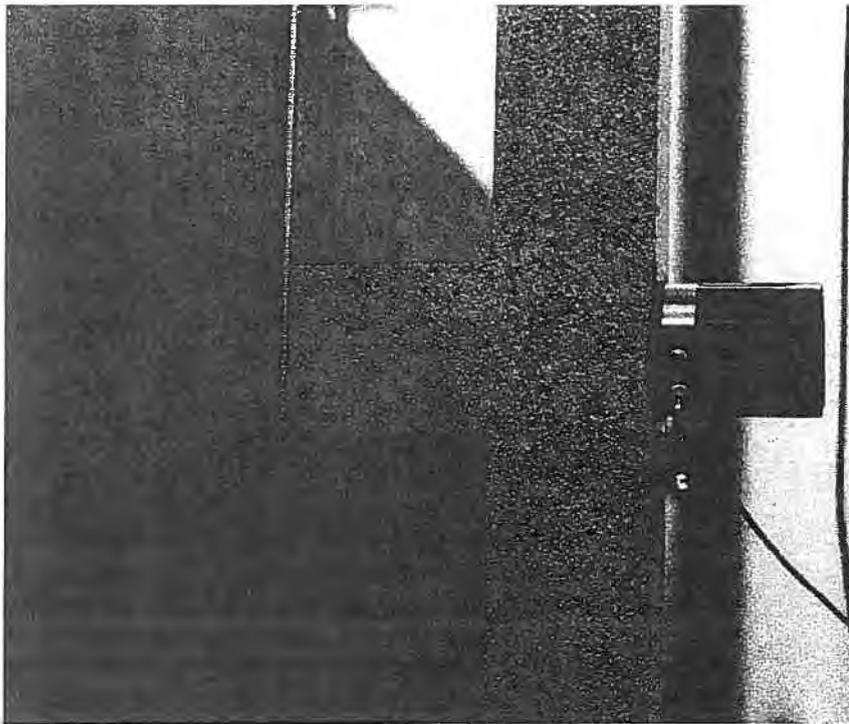
Pictures of the cracks at the middle node at the second storey and at the right node at the second storey are shown in Figures 11 and 12 after EQ1 and in Figures 13 and 14 after EQ2. Only at the nodes in the second and third storeys significant localized permanent deformations were found. The node numbers are at first storey are 1,2 and 3, at second storey 4,5 and 6 etc. During the third strong motion event both the second and third storey collapsed completely and the first storey suffered severe damage. A picture of the collapsed structure is shown in Figure 15. A classification of the damage as described in section 2.2 is given in Table 5.

**Figure 11:** *Cracks in node 5 after EQ1.*
