DAMAGES IN CONCRETE RAILWAY SLEEPERS IN FINLAND

Pirjo Tepponen, Bo-Erik Eriksson
Lohja Corporation, Product Development

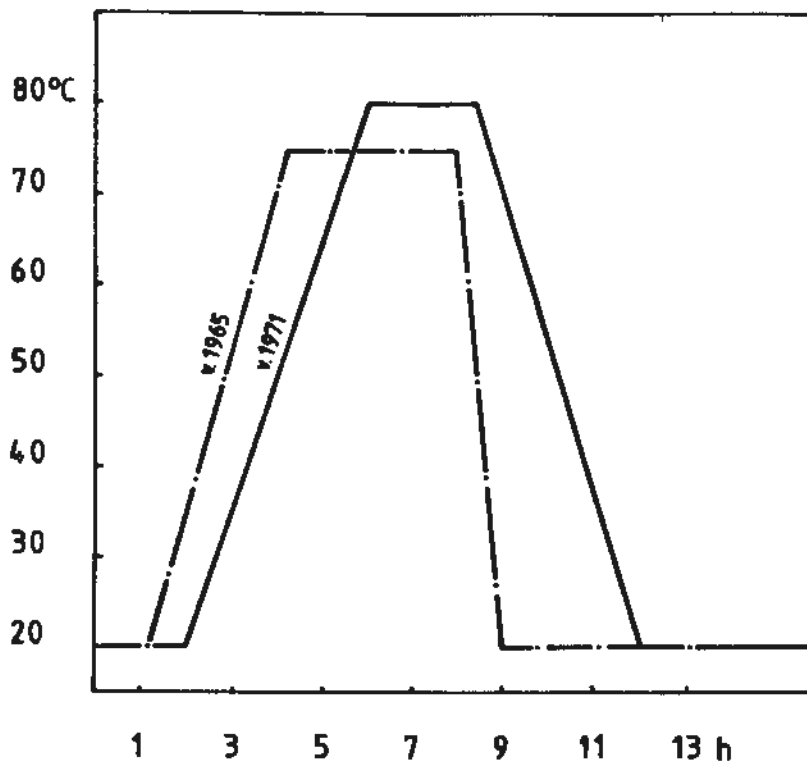
Figure 2. Thermal profiles of sleeper concrete in two different years

Initial storage was from 1 to 2 hours and it took about 3 to 4 hours for the temperature to reach its maximum. The maximum temperature measured in the tent was 75 to 80°C. Maximum temperature remained stable for 2.5 to 4 hours. Therefore it seems probable that the temperature inside the concrete was even higher.

The results showed that the main reason for the deterioration problem was poor frost resistance of the concrete. To eliminate the problem, additional air-entraining agent was adopted and the maximum temperature in the tent was brought down from 80°C to 60°C, while the rate of temperature raising remained unchanged (see figure 2).
